CONDITION REPORT

Report No:
2017315458
DATE
22/10/2026

Vehicle Type	PASSENGER VEHICLE	Registered Owner	
Manufacturer	SUZUKI	Registration Number	KS80LSGP
Model	DZIRE 1.2 GA MC [2020-2025]	Register Number	
VIN	MBHCZF63S00264853	Date Of First Licensing	
Engine Number		Last COR	
Doors	5	License Expiry Date	31/01/2027
Color	GREY	Power / Displacement	
Year Model	2022	Paint Finish	C - COMMON
Km Reading	216,891 KM	Fuel	PETROL
Cab / Body Type	SEDAN	Transmission	MANUAL

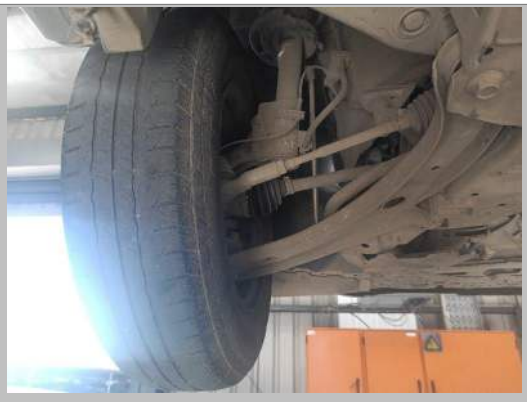
LF TYRE TREAD

Size	Load/Speed Index	Manufacture	Model	Type*	Production Date	Tread Depth (mm)
Front Left	165/80R14	85T	Apollo	Amazer	V	4021	1 mm
Front Right	165/80R14	85T	Apollo	Amazer	V	4723	4 mm
Rear Left	165/60R14	85T	Apollo	Amazer	V	4723	3 mm
Rear Right	165/80R14	85T	Apollo	Amazer	V	0224	4 mm
Spare	T135/70R15	99m	Jktyre	Staraxt	V	3323	4 mm

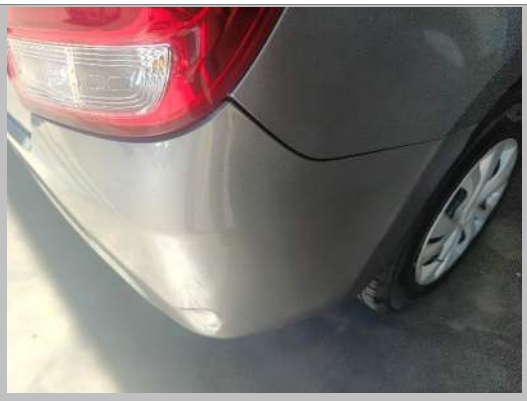
Damage	Repair Way
Engine Water Leak	Repair
Headlight Right Damaged	Repair
Door Sealing Rubber Rear Left Missing	Replace
Door Sealing Rubber Rear Right Defective	Repair
Carpet Rear Damaged	Replace
Front Bumper Damaged	Repair
Front Fender Left Dented	Repair
Front Fender Right Residual Traces of Repair	Repair
Rear Fender Left Dented	Repair
Rear Fender Right Dented	Repair
Front Fender Left / Inner Tray Damaged	Repair
Front Fender Right / Inner Tray Damaged	Repair
Door Front Left Dented	Repair
Door Front Right Damaged	Repair
Door Rear Left Paintwork • Scratched	Repair
Door Rear Right Dented	Repair
Boot Lid / Hatch door Residual Traces of Repair	Repair
Rear bumper Damaged	Repair
Windscreen Cracked	Replace
Tyre Front Right Torn / Cut	Replace
Tyre Rear Right Defective	Repair
Main Beam Right Damaged	Repair
Sub Frame Dented	Repair
Belly plates Damaged	Replace
Radiator Cross Member Damaged	Repair
Front right Head light bracket damaged	Repair
