CONDITION REPORT

Report No:
2017312883
DATE
15/10/2026

Vehicle Type	PASSENGER VEHICLE	Registered Owner	MFC
Manufacturer	NISSAN	Registration Number	JF58CGGP
Model	ALMERA 1.5 ACENTA [2016-2023]	Register Number	
VIN	MDHBBAN17Z0727349	Date Of First Licensing	
Engine Number		Last COR	
Doors	4	License Expiry Date	31/05/2026
Color	SILVER	Power / Displacement	
Year Model	2019	Paint Finish	M - METALLIC
Km Reading	135,944 KM	Fuel	PETROL
Cab / Body Type	SEDAN	Transmission	MANUAL

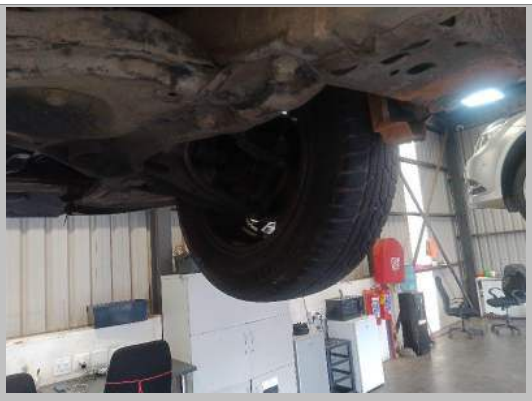
LR TYRE TREAD

Body exterior	Signs of spray work done on some body panels
All four tires deferred name brand	Repair
Antenna missing	Replace
