CONDITION REPORT

Report No:
2017290164
DATE
26/08/2026

Vehicle Type	PASSENGER VEHICLE	Registered Owner	MFC
Manufacturer	NISSAN	Registration Number	JC49XFGP
Model	ALMERA 1.5 ACENTA AT [2016-2024]	Register Number	
VIN	MDHBBAN17Z0727666	Date Of First Licensing	
Engine Number		Last COR	
Doors	4	License Expiry Date	31/03/2027
Color	SILVER	Power / Displacement	
Year Model	2019	Paint Finish	TWO COAT METALLIC
Km Reading	318,175 KM	Fuel	PETROL
Cab / Body Type	SEDAN	Transmission	AUTOMATIC

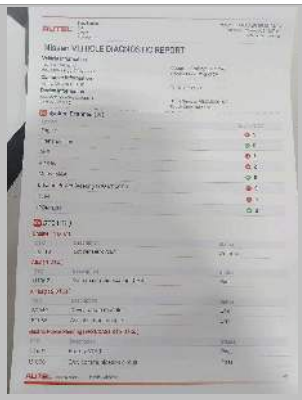
Diagnostic.

No	System	Code	Description	Status
1	ENGINE	P0118	ECT SENSER/CIRCUIT

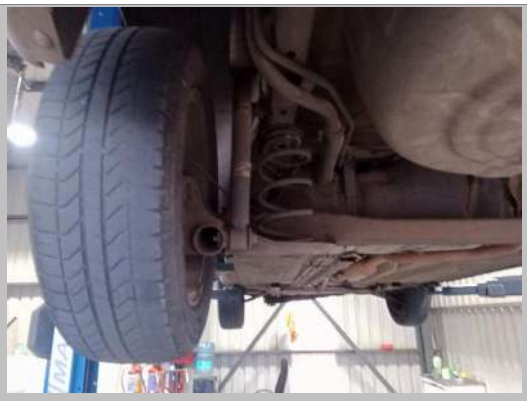
LF TYRE TREAD

Size	Load/Speed Index	Manufacture	Model	Type*	Production Date	Tread Depth (mm)
Front Left	185/65R15	88H	Falken	Radial	V	3219	0 mm
Front Right	185/65R15	88H	Annaite	Radial	V	4024	0 mm
Rear Left	185/65R15	92H	Sumitomo	Radial	V	2921	0 mm
Rear Right	185/65R15	88H	Goodyear	Efficient	V	2724	0 mm
Spare	185/65R14	89H	Goodyear	Eagle	V	2323	1 mm

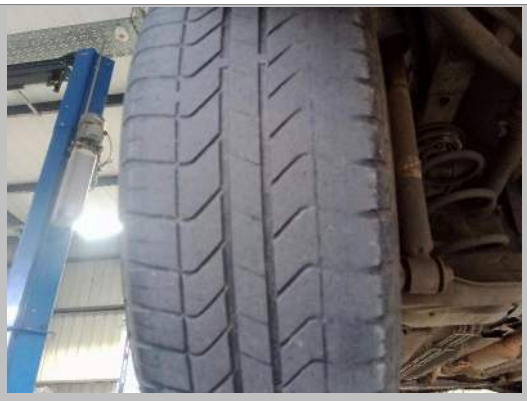
Damage	Repair Way
Engine Oil Leak	Repair
Bonnet stay and shocks Damaged	Replace
Engine Management Lights Set	Repair
Tail Light Left Damaged	Replace
Tail Light Right Damaged	Replace
Seat Front Right Damaged	Replace
Door Panel Front Right Damaged	Replace
Steering Wheel Trim Damaged	Replace
Front Bumper Damaged	Repair
Bonnet Damaged	Repair
Front Fender Left Damaged	Repair
Front Fender Right Damaged	Repair
Rear Fender Left Damaged	Repair
Rear Fender Right Damaged	Repair
Door Front Left Damaged	Repair
Door Front Right Damaged	Repair
Door Rear Left Damaged	Repair
Door Rear Right Damaged	Repair
Boot Lid / Hatch door Damaged	Repair
Rear bumper Damaged	Repair
Tyre Front Left Worn	Replace
Tyre Front Right Worn	Replace
Tyre Rear Left Worn	Replace
Tyre Rear Right Worn	Replace
Gearbox Oil Leak	Repair
