CONDITION REPORT

Report No:
2017315648
DATE
22/10/2026

Vehicle Type	PASSENGER VEHICLE	Registered Owner	
Manufacturer	NISSAN	Registration Number	KN25MNGP
Model	ALMERA 1.5 ACENTA [2016-2023]	Register Number	
VIN	MDHBBAN17Z0736229	Date Of First Licensing	
Engine Number		Last COR	
Doors	4	License Expiry Date	30/04/2027
Color	WHITE	Power / Displacement	
Year Model	2022	Paint Finish	C - COMMON
Km Reading	214,313 KM	Fuel	PETROL
Cab / Body Type	SEDAN	Transmission	MANUAL

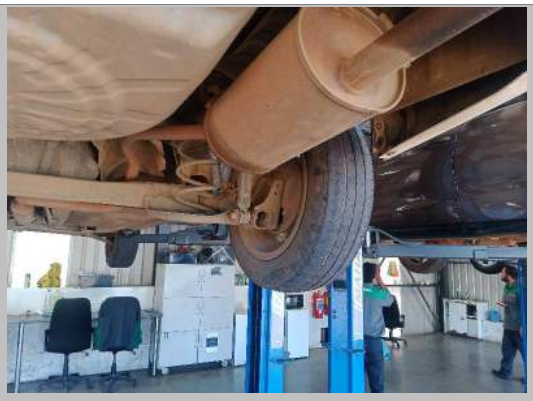
RF TYRE TREAD

Size	Load/Speed Index	Manufacture	Model	Type*	Production Date	Tread Depth (mm)
Front Left	195/65R15	91V	Win run	R330	V	1021	2 mm
Front Right	195/65R15	91V	Win run	R330	V	1021	2 mm
Rear Left	185/65R15	88H	Tomket	Eco	V	3024	0 mm
Rear Right	175/65R15	84T	Bridgestone	Ecopia	V	4113	0 mm
Spare	185/65R15	88H	Goodyear	Efficient gr	V	0000	3 mm

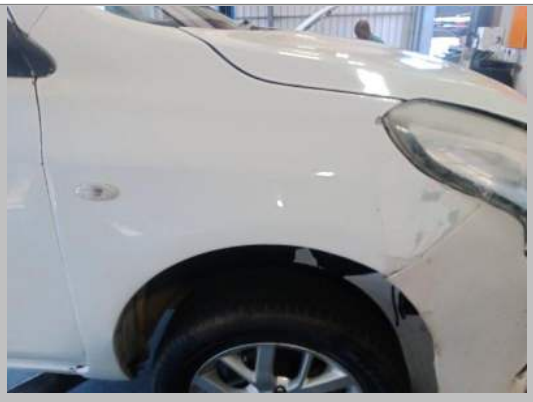
Damage	Repair Way
Air cleaner Damaged	Repair
Bonnet stay and shocks Missing	Replace
Hooter Defective	Repair
Headlight Right Damaged	Repair
Seat Front Right Damaged	Repair
Seat Rear Torn / Cut	Repair
Carpet Rear Dirty	Repair
Side Mirror Left Paintwork • Scratched	Repair
Front Bumper Residual Traces of Repair	Repair
Bonnet Residual Traces of Repair	Repair
Front Fender Left Paintwork • Discoloured	Repair
Front Fender Right Residual Traces of Repair	Repair
Rear Fender Left Paintwork • Scratched	Repair
Rear Fender Right Paintwork • Scratched	Repair
Door Front Left Paintwork • Discoloured	Repair
Door Front Right Paintwork • Scratched	Repair
Door Rear Left Paintwork • Scratched	Repair
Door Rear Right Paintwork • Scratched	Repair
Boot Lid / Hatch door Paintwork • Scratched	Repair
Rear bumper Paintwork • Scratched	Repair
Roof Dented	Repair
Windscreen Chipped	Repair
Tyre Rear Left Smooth	Replace
Tyre Rear Right Smooth	Replace
