CONDITION REPORT

Report No:
2017314847
DATE
20/10/2026

Vehicle Type	PASSENGER VEHICLE	Registered Owner	
Manufacturer	NISSAN	Registration Number	LDP584NW
Model	MAGNITE TURBO 1.0T ACENTA W/O LED 5-DR CVT [2022-2024]	Register Number	
		Date Of First Licensing	
VIN	MDHFBADD0Z0008331	Last COR	
Engine Number		License Expiry Date	30/11/2026
Doors	5	Power / Displacement	
Color	SILVER	Paint Finish	C - COMMON
Year Model	2022	Fuel	PETROL
Km Reading	58,377 KM	Transmission	AUTOMATIC
Cab / Body Type	HATCHBACK

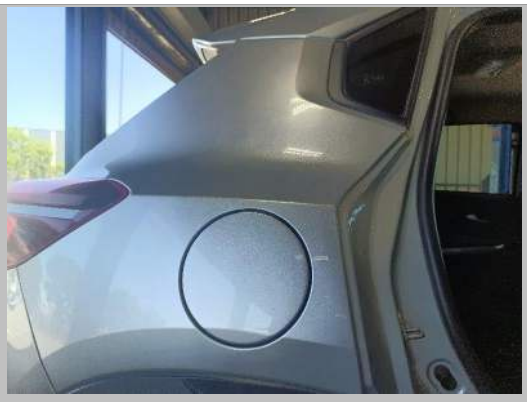
Damage	Repair Way
Center Console / Cubbyhole + Lid Defective	Repair
Front Bumper Paintwork • Scratched	Repair
Rear Fender Right Residual Traces of Repair	Repair
Door Front Right Residual Traces of Repair	Repair
Door Rear Left Paintwork • Scratched	Repair
Door Rear Right Residual Traces of Repair	Repair
Sealing / Rubber Front Door Right Defective	Repair
Sealing / Rubber Rear Door Left Defective	Replace
Boot Lid / Hatch door Paintwork • Scratched	Repair
Rear bumper Damaged	Repair
Reverse Camera damaged or Faulty	Repair
Rear Bumper some bolts missing	Repair
Warning light illuminated	Repair
