CONDITION REPORT

Report No:
2017316038
DATE
22/10/2026

Vehicle Type	PASSENGER VEHICLE	Registered Owner	MFC AUCTION HOUSE
Manufacturer	NISSAN	Registration Number	LGF070NW
Model	MAGNITE	Register Number	
VIN	MDHFBADD0Z0009549	Date Of First Licensing	
Engine Number		Last COR	
Doors	5	License Expiry Date	31/05/2027
Color	WHITE	Power / Displacement	
Year Model		Paint Finish	C - COMMON
Km Reading	54,035 KM	Fuel	PETROL
Cab / Body Type	HATCHBACK	Transmission	AUTOMATIC

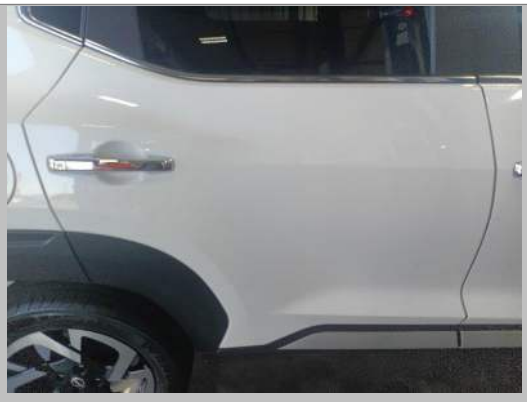
Damage	Repair Way
Engine Oil Sweat	Repair
Door Sealing Rubber Front Right Worn	Repair
Front Bumper Paintwork • Scratched	Repair
Rear Fender Right Paintwork • Scratched	
Front Fender Right / Inner Tray Cracked	Repair
Door Rear Left Dented	Repair
Door Rear Right Dented	Repair
Boot Lid / Hatch door Residual Traces of Repair	Repair
Gearbox Oil Sweat	Repair
Body exterior	body has minor dents and scratches chip
Engine warning lights illumunated	Repair
