CONDITION REPORT

Report No:
2017316365
DATE
28/10/2026

Vehicle Type	PASSENGER VEHICLE	Registered Owner	
Manufacturer	NISSAN	Registration Number	LW68ZJGP
Model	MICRA ACTIVE 1.2 VISIA 5-DR [2017-2018]	Register Number	
VIN	MDHFBUK13Z0302040	Date Of First Licensing	
Engine Number		Last COR	
Doors	5	License Expiry Date	31/07/2025
Color	GREEN	Power / Displacement	
Year Model	2017	Paint Finish	TWO COAT METALLIC
Km Reading	1,234 KM	Fuel	PETROL
Cab / Body Type	HATCHBACK	Transmission	MANUAL

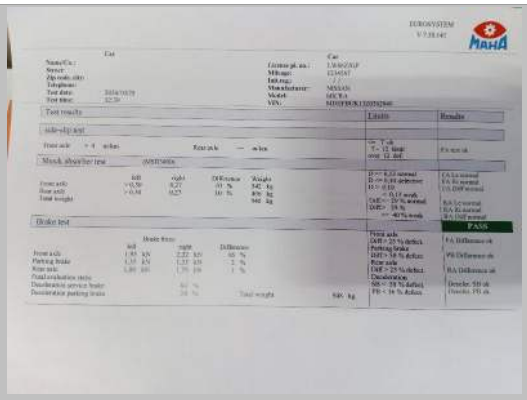
Brake test.

Left	Right		
	Braking Force [KN]	Braking Force [KN]	Axle Weight [KG]	Deceleration [m/s²]
Front	1.95	2.32	-	
Rear	1.8	1.79	-	
Emergency / Parking	1.35	1.33	-

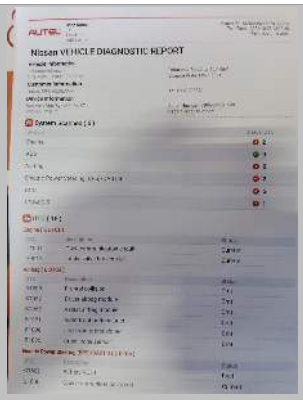
Diagnostic.

No	System	Code	Description	Status
1	ENGINE	U1001	CAN COMMUNICATION CIRCUIT

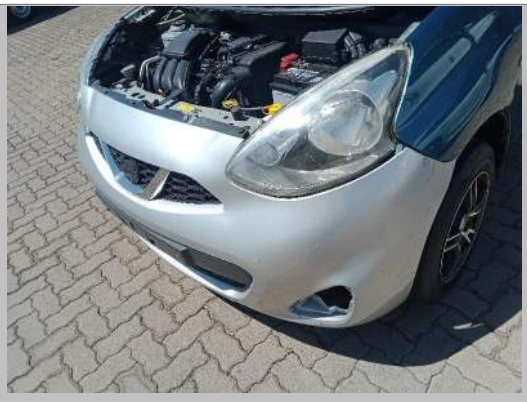
Damage	Repair Way
Engine Wiring Damaged	Replace
Fuel Gauge Defective	Repair
Ref Counter Defective	Repair
Hooter Defective	Repair
Engine Management Lights Set	Repair
Windscreen Wiper Damaged	Repair
Headlight Left Damaged	Replace
Headlight Right Damaged	Replace
Dash Padding Damaged	Replace
Steering Wheel Trim Damaged	Replace
Side Mirror Right Damaged	Replace
Front Bumper Damaged	Repair
Bonnet Damaged	Repair
Bonnet slam plate (Shock tower/ Inner tray) Damaged	Repair
A • Pillar Right Damaged	Repair
Front Fender Left Damaged	Repair
Front Fender Right Damaged	Repair
Rear Fender Left Damaged	Repair
Rear Fender Right Damaged	Repair
Door Front Left Damaged	Repair
Door Front Right Damaged	Repair
Door Rear Left Damaged	Repair
Door Rear Right Damaged	Repair
Boot Lid / Hatch door Damaged	Repair
Rear bumper Damaged	Repair
Roof Damaged	Repair
Windscreen Damaged	Replace
Gearbox Oil Leak	Repair
CV Joint(s) Boot(s) Front Left (inner/outer) Damaged	Replace

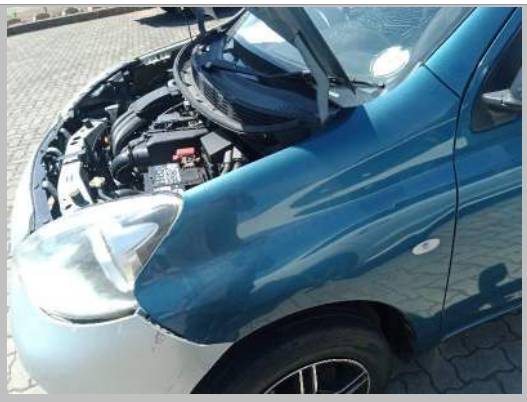
Bonnet slam plate (Shock tower/ Inner tray)

Radiator Cradle Damaged	Replace
Brakes Insufficient	Repair
Engine Noise Excessive	Repair
Rear tyres size differs	Replace

General Comments: ACCORDING TO THE AGE AND MILEAGE OF THE VEHICLE, NORMAL WEAR AND TEAR MARKS ARE VISIBLE ON THE INTERIOR, EXTERIOR, ELECTRICAL AND MECHANICAL PARTS. 16 DTC'S AT TIME OF TESTING SEE DTC REPORT.Engine Compartment: Battery loose. Sump damaged.
Electrical Components and Instruments: radio antenna missing.
Interior: signs of vehicle airbags deployed. cluster does not work.
Body • Exterior: Minor dents and scratches and stone chips to body panels. Signs of repair work done to body panels. Poor alignment to somebody panels. Repair work done to vehicle below standard. Vehicle body in poor condition. Signs of impact damage to front of vehicle.
Tyres and Rims: rear wheel sizes do not match.
