CONDITION REPORT

Report No:
2017317127
DATE
26/10/2026

Vehicle Type	PASSENGER VEHICLE	Registered Owner	MFC
Manufacturer	DATSUN	Registration Number	KFD378MP
Model	GO+ 1.2 MC LUX 7-S MPV [2018-2021]	Register Number	
VIN	MDHJBAAD0Z0503418	Date Of First Licensing	
Engine Number		Last COR	
Doors	5	License Expiry Date	31/10/2026
Color	BROWN	Power / Displacement	
Year Model	2019	Paint Finish	TWO COAT METALLIC
Km Reading	151,942 KM	Fuel	PETROL
Cab / Body Type	HATCHBACK	Transmission	MANUAL

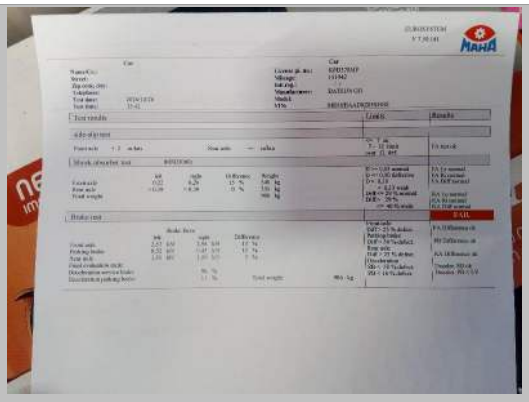
Brake test.

Left	Right		
	Braking Force [KN]	Braking Force [KN]	Axle Weight [KG]	Deceleration [m/s²]
Front	2.57	2.94	-	
Rear	1.51	1.56	-	
Emergency / Parking	0.52	0.45	-

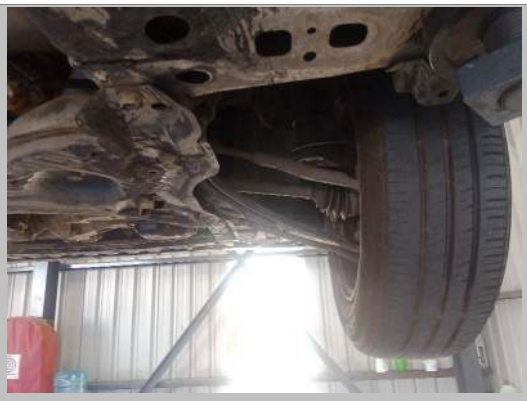
LF TYRE TREAD

Size	Load/Speed Index	Manufacture	Model	Type*	Production Date	Tread Depth (mm)
Front Left	175/65R14	82H	Aplus	Radial	V	1622	2 mm
Front Right	175/65R14	82H	Aplus	Radial	V	1625	1 mm
Rear Left	175/65R14	82T	Roadstone	Radial	V	0221	1 mm
Rear Right	175/65R14	82T	Roadstone	Radial	V	2721	2 mm
Spare	165/70R14	81T	MRF	Radial	V	0000	2 mm

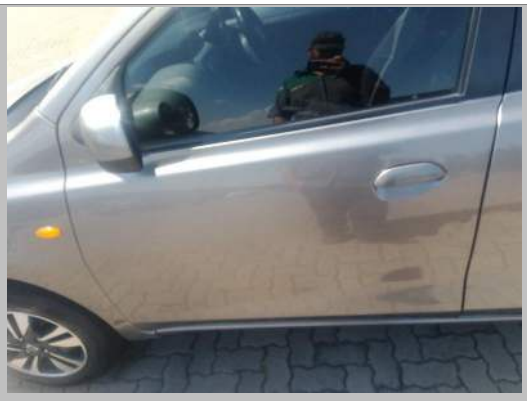
Damage	Repair Way
Seat Front Right Damaged	Repair
Front Bumper Damaged	Repair
Bonnet Damaged	Repair
Front Fender Left Damaged	Repair
Front Fender Right Damaged	Repair
Rear Fender Right Damaged	Repair
Door Front Left Damaged	Repair
Door Front Right Damaged	Repair
Door Rear Left Damaged	Repair
Door Rear Right Damaged	Repair
Boot Lid / Hatch door Damaged	Repair
Boot Lid / Hatch Door Shock Left Damaged	Repair
Boot Lid / Hatch Door Shock Right Damaged	Repair
Rear bumper Damaged	Repair
Shock Absorber Rear Left Worn	Replace
Tyre Rear Right Worn	Replace

General Comments: ACCORDING TO THE AGE AND MILEAGE OF THE VEHICLE, NORMAL WEAR AND TEAR MARKS ARE VISIBLE ON THE INTERIOR, EXTERIOR, ELECTRICAL AND MECHANICAL PARTS.Body • Exterior: Minor dents and scratches and stone chips to body panels. Signs of repair work done to body panels. Poor alignment to somebody panels. Vehicle body in poor condition. signs of surface rust to somebody panels.
