CONDITION REPORT

Report No:
2017315454
DATE
21/10/2026

Vehicle Type	PASSENGER VEHICLE	Registered Owner	MFC AUCTION HOUSE
Manufacturer	DATSUN	Registration Number	KF70CTGP
Model	GO 1.2 MC MID 5-DR [2018-2022]	Register Number	
VIN	MDHZBAAD0Z0513822	Date Of First Licensing	
Engine Number		Last COR	
Doors	5	License Expiry Date	
Color	WHITE	Power / Displacement	
Year Model	2019	Paint Finish	C - COMMON
Km Reading	167,836 KM	Fuel	PETROL
Cab / Body Type	HATCHBACK	Transmission	MANUAL

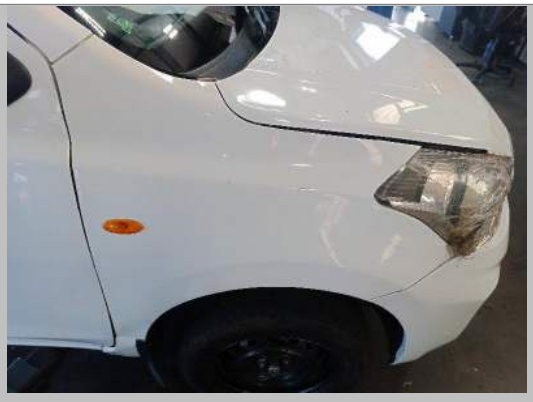
Damage	Repair Way
Engine Oil Leak	Repair
Bonnet stay and shocks Missing	Replace
Radio/CD/USB Defective	Repair
Headlight Right Damaged	Replace
Seat Front Right Damaged	Repair
Front Bumper Damaged	Repair
Grill Damaged	Repair
Bonnet Paintwork • Chipmarks	Repair
Front Fender Left Dented	Repair
Front Fender Right Residual Traces of Repair	Repair
Rear Fender Left Dented	Repair
Rear Fender Right Dented	Repair
Door Front Left Residual Traces of Repair	Repair
Door Front Right Dented	Repair
Door Rear Left Dented	Repair
Door Rear Right Paintwork • Scratched	Repair
Boot Lid / Hatch door Paintwork • Scratched	Repair
Rear bumper Paintwork • Scratched	Repair
Sill Panel Right Paintwork • Scratched	Repair
Roof Paintwork • Flaking	Repair
Shock Absorber Rear Left Leak	Replace
Tyre Front Right Smooth	Replace
Gearbox Mountings Defective	Repair
CV Joint(s) Boot(s) Front Left (inner/outer) Damaged	Repair
CV Joint(s) Boot(s) Front Right (inner/outer) Damaged	Replace
