CONDITION REPORT

Report No:
2017327231
DATE
18/11/2026

Vehicle Type	PASSENGER VEHICLE	Registered Owner	
Manufacturer	DATSUN	Registration Number	CK01FRZN
Model	GO 1.2 LUX 5-DR CVT [2019-2022]	Register Number	
VIN	MDHZBAAD0Z0519647	Date Of First Licensing	
Engine Number		Last COR	
Doors	5	License Expiry Date	
Color	WHITE	Power / Displacement	
Year Model	2021	Paint Finish	C - COMMON
Km Reading	72,612 KM	Fuel	PETROL
Cab / Body Type	HATCHBACK	Transmission	AUTOMATIC

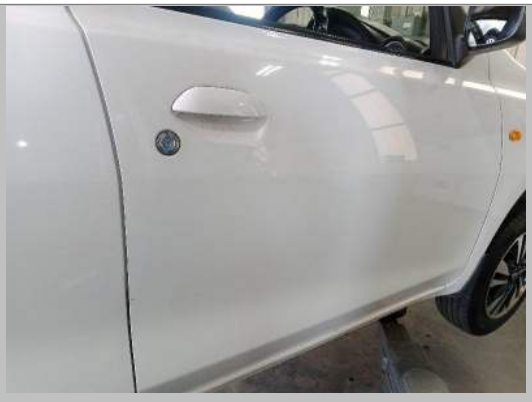
Damage	Repair Way
Headlight Right Damaged	Replace
Front Bumper Paintwork • Scratched	Repair
Bonnet Paintwork • Chipmarks	Repair
Front Fender Left Paintwork • Chipmarks	Repair
Front Fender Right Paintwork • Chipmarks	Repair
Rear Fender Right Dented	Repair
Door Front Left Paintwork • Scratched	Repair
Door Front Right Paintwork • Scratched	Repair
Door Rear Right Paintwork • Scratched	Repair
Rear bumper Paintwork • Scratched	Repair
Tyre Rear Right Smooth	Replace
Body exterior	Vehicle got minor scratches, stone chips and dents
