CONDITION REPORT

Report No:
2017305041
DATE
29/09/2026

Vehicle Type	PASSENGER VEHICLE	Registered Owner	MFC
Manufacturer	RENAULT	Registration Number	HZ61YKGP
Model	KWID/ HATCH BACK	Register Number	
VIN	MEEBBA00100658483	Date Of First Licensing	
Engine Number		Last COR	
Doors	5	License Expiry Date	
Color	SILVER	Power / Displacement	
Year Model		Paint Finish	M - METALLIC
Km Reading	102,227 KM	Fuel	PETROL
Cab / Body Type	HATCHBACK	Transmission	MANUAL

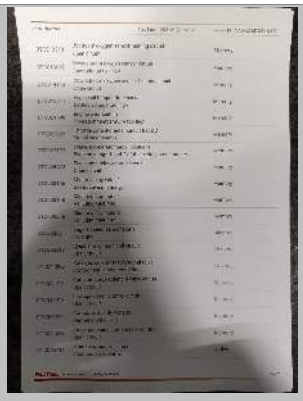
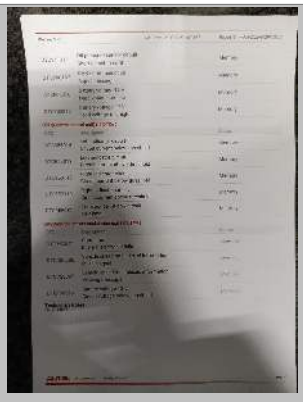
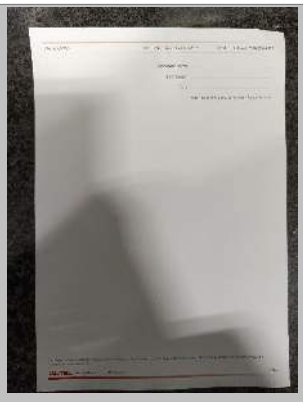
Diagnostics report

No	System	Code	Description	Status
1	AIRB	DTC800113	DRIVER FRONT AIR BAG CIRCUIT 1 OPEN CIRCUIT	
2	INJECTION	DTC065711	MAIN RELAY CONTROL CIRCUIT SHORT CIRCUIT TO 6

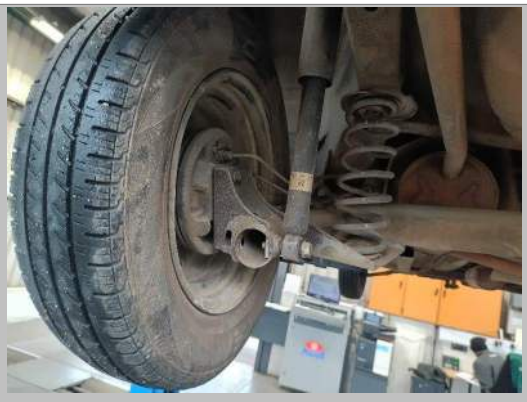
LR TYRE TREAD

Size	Load/Speed Index	Manufacture	Model	Type*	Production Date	Tread Depth (mm)
Front Left	155/80R13	79T	Ceat	Milaze	V	0619	2 mm
Front Right	155/80R13	79T	Sumitomo	HTR	V	4122	0 mm
Rear Left	155/80R13	79T	Ceat	Miaze	V	0619	3 mm
Rear Right	155/80R13	79T	Dunlop	Sport	V	3715	0 mm
Spare	155/70R13	79T	Dunlop	Sports	V	//////////	0 mm

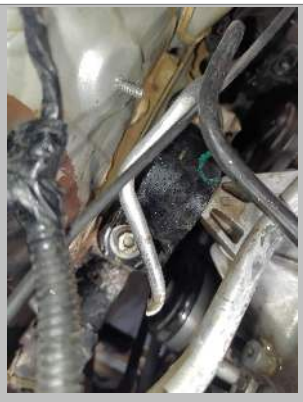
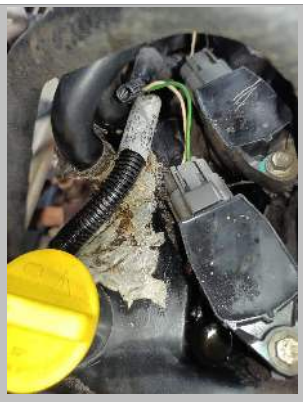
Damage	Repair Way
Engine Damaged	Repair
Air conditioner pipes Damaged	Repair
Indicator Light Front Right Damaged	Replace
Fuse box and fuses Defective	Repair
Door Handle Front Right Missing	Replace
Door Handle Rear Right Missing	Replace
Parcel Tray Missing	Replace
Window Winder rear right Missing	Replace
Front Bumper Damaged	Repair
Bonnet Residual Traces of Repair	Repair
Bonnet slam plate (Shock tower/ Inner tray) Damaged	Replace
Front Fender Left Residual Traces of Repair	Repair
Front Fender Right Residual Traces of Repair	Repair
Rear Fender Left Paintwork • Scratched	Repair
Rear Fender Right Residual Traces of Repair	Repair
Door Front Right Residual Traces of Repair	Repair
Door Rear Right Residual Traces of Repair	Repair
Boot Lid / Hatch door Residual Traces of Repair	Repair
Windscreen Cracked	Replace
Rear Axle Damaged	Replace
Control Arm Bush(es) Front Axle Left Cracked	Replace
Tyre Front Right Smooth	Replace
