CONDITION REPORT

Report No:
2017324314
DATE
11/11/2026

Vehicle Type	PASSENGER VEHICLE	Registered Owner	MFC
Manufacturer	RENAULT	Registration Number	LK21BKGP
Model	KWID	Register Number	
VIN	MEEBBA00300848446	Date Of First Licensing	
Engine Number		Last COR	
Doors	5	License Expiry Date	31/05/2027
Color	GREEN	Power / Displacement	
Year Model		Paint Finish	TWO COAT METALLIC
Km Reading	130,945 KM	Fuel	PETROL
Cab / Body Type	HATCHBACK	Transmission	MANUAL

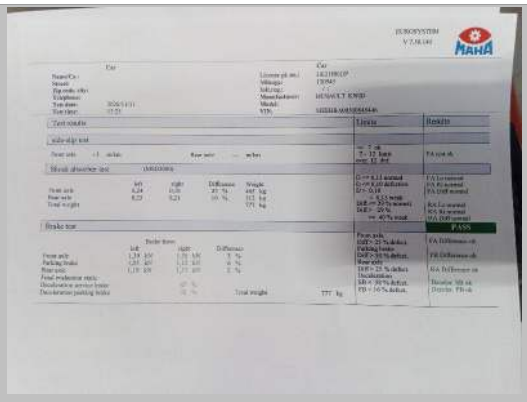
Brake test.

Left	Right		
	Braking Force [KN]	Braking Force [KN]	Axle Weight [KG]	Deceleration [m/s²]
Front	1.39	1.35	-	
Rear	1.19	1.17	-	
Emergency / Parking	105	1.12	-

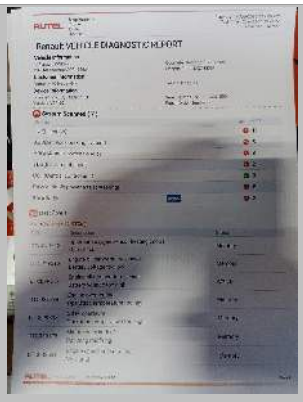
Diagnostic.

No	System	Code	Description	Status
1	INJ	DTC013513	ENGINE OIL TEMPERATURE SENSOR BATTERY VOLTAGE TOO HIGH	ACTIVE

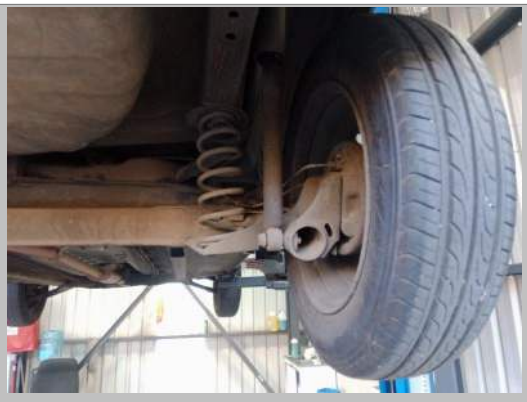
Size	Load/Speed Index	Manufacture	Model	Type*	Production Date	Tread Depth (mm)
Front Left	165/70R14	81T	Ceat	Radial	V	3123	0 mm
Front Right	165/70R14	81H	Ceat	Radial	V	1723	2 mm
Rear Left	165/70R14	81T	Firemax	Radial	V	4625	2 mm
Rear Right	165/70R14	81T	Firemax	Radial	V	4425	2 mm

LF TYRE TREAD

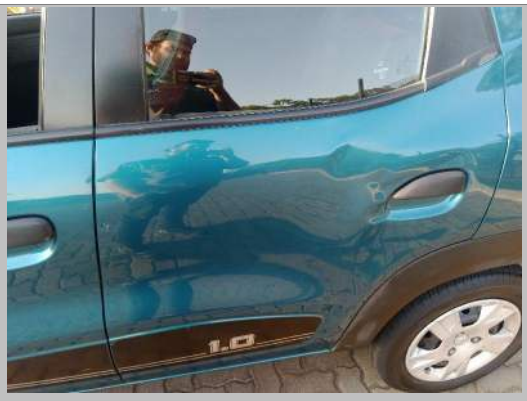
Damage	Repair Way
Engine Oil Leak	Repair
Engine Management Lights Set	Repair
Headlight Right Damaged	Replace
Front Bumper Damaged	Repair
Bonnet Damaged	Repair
Front Fender Left Damaged	Repair
Front Fender Right Damaged	Repair
Rear Fender Right Damaged	Repair
Door Front Left Damaged	Repair
Door Front Right Damaged	Repair
Door Rear Left Damaged	Repair
Door Rear Right Damaged	Repair
Boot Lid / Hatch door Damaged	Repair
Rear bumper Damaged	Repair
Roof Damaged	Repair
Tyre Front Left Worn	Replace
Main Beam Right Damaged	Replace
Gearbox Oil Leak	Replace
Engine Performance Insufficient	Repair
Engine Noise Excessive	Repair
