CONDITION REPORT

Report No:
2017309675
DATE
09/10/2026

Vehicle Type	PASSENGER VEHICLE	Registered Owner	MFC
Manufacturer	RENAULT	Registration Number	BN99SKZN
Model	KWID	Register Number	
VIN	MEEBBA00400828769	Date Of First Licensing	
Engine Number		Last COR	
Doors	5	License Expiry Date	
Color	SILVER	Power / Displacement	
Year Model		Paint Finish	M - METALLIC
Km Reading	78,659 KM	Fuel	PETROL
Cab / Body Type	HATCHBACK	Transmission	MANUAL

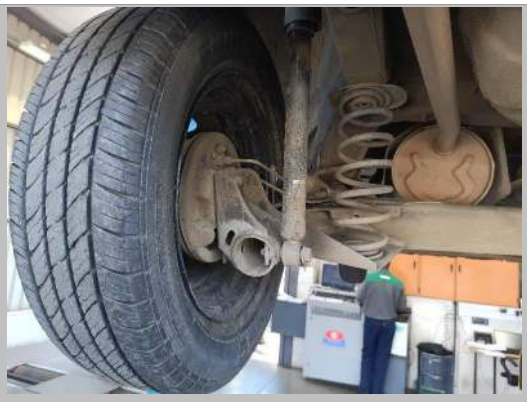
LR TYRE TREAD

Size	Load/Speed Index	Manufacture	Model	Type*	Production Date	Tread Depth (mm)
Front Left	165/70R14	81H	Lanvigator	Comfort	V	4542	1 mm
Front Right	165/70R14	81H	Lanvigator	Comfort	V	4524	1 mm
Rear Left	165/70R13	79H	Sinful	SF	V	1119	4 mm
Rear Right	165/80R13	83T	Firesmax	FM601	V	0124	4 mm
Spare	165/70R14	81T	Ceat	Fuelsmart	V	0000	0 mm

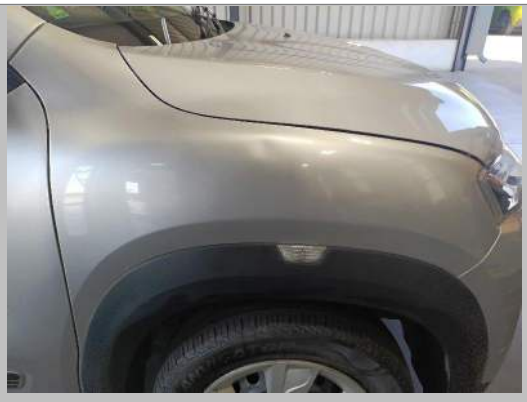
Damage	Repair Way
Engine Oil Leak	Repair
Clamps Damaged	Repair
Dim Light Left Defective	Repair
Seat Front Right Torn / Cut	Repair
Door Lock Boot Lid Damaged	Repair
Front Bumper Paintwork • Scratched	Repair
Front Fender Left Dented	Repair
Front Fender Right Dented	Repair
Door Rear Right Paintwork • Scratched	Repair
Boot Lid / Hatch door Damaged	Repair
Windscreen Cracked	Replace
Control Arm Bush(es) Front Axle Left Cracked	Replace
Control Arm Bush(es) Front Axle Right Cracked	Replace
Spare Tyre Smooth	Replace
Body exterior	Signs of spray work done on body panels
Body exterior	Minor dents scratches stone chips on body panels
Rear tyre size	Replace
