CONDITION REPORT

Report No:
2017315589
DATE
21/10/2026

Vehicle Type	PASSENGER VEHICLE	Registered Owner	MFC AUCTION HOUSE
Manufacturer	RENAULT	Registration Number	MH25WMGP
Model	KWID	Register Number	
VIN	MEEBBA00400832630	Date Of First Licensing	
Engine Number		Last COR	
Doors	5	License Expiry Date	30/04/2027
Color	SILVER	Power / Displacement	
Year Model		Paint Finish	C - COMMON
Km Reading	102,466 KM	Fuel	PETROL
Cab / Body Type	HATCHBACK	Transmission	MANUAL

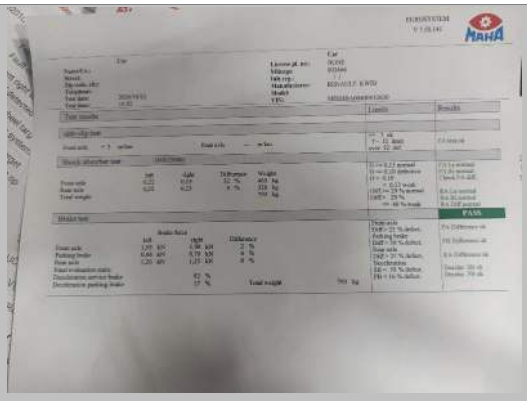
Brake report

Left	Right		
	Braking Force [KN]	Braking Force [KN]	Axle Weight [KG]	Deceleration [m/s²]
Front	1.9	1.9	-	
Rear	1.2	1.2	-	
Emergency / Parking	0.6	0.7	-

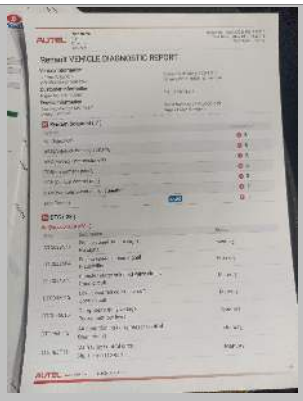
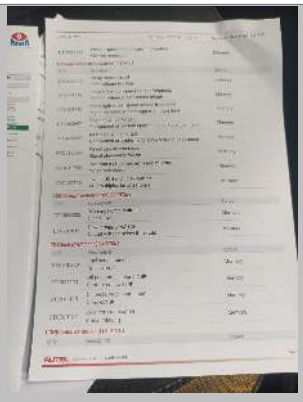
diagnostics

No	System	Code	Description	Status
1	INJECTION	DTC033531	ENGINE SPEED SENSOR SIGNAL NO SIGNAL

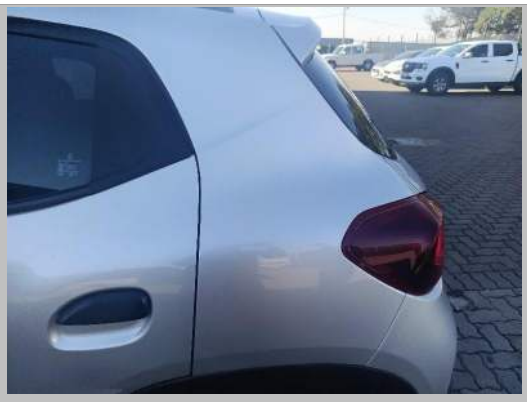
Damage	Repair Way
Engine Oil Leak	Repair
Headlight Right Damaged	Replace
Number Plate Front Missing	Replace
Number Plate Rear Missing	Replace
Front Bumper Damaged	Repair
Bonnet Dented	Repair
Front Fender Right Residual Traces of Repair	Repair
Rear Fender Left Dented	Repair
Front Fender Left / Inner Tray Cracked	Replace
Door Front Left Paintwork • Scratched	Repair
Door Front Right Residual Traces of Repair	Repair
Door Rear Left Paintwork • Scratched	
Door Rear Right Damaged	Repair
Boot Lid / Hatch door Dented	Repair
Inner Boot Floor Pan and Spare Wheel Well Damaged	Repair
Windscreen Chipped	Repair
Control Arm Bush(es) Front Axle Left Cracked	Replace
Gearbox Oil Sweat	Repair
Body exterior	residual traces of poor repair below standard
