# CONDITION REPORT

**Report No:**
**2017312585**
**DATE**
**15/10/2026**

| Manufacturer | RENAULT | Registration Number | KC98YMGP |
| Model | KWID | Register Number | |

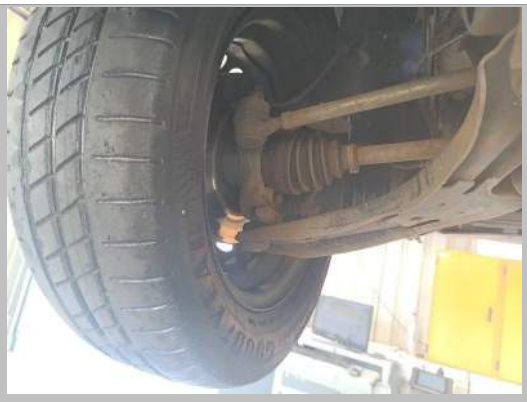
LF TYRE TREAD

| Damage | Repair Way |
|---|---|
| Tyre Front Left Excessive Wear & Tear | Replace |

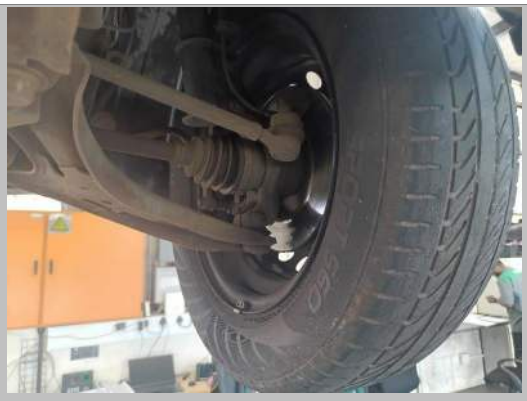
RF TYRE TREAD

| Damage | Repair Way |
|---|---|
| Tyre Front Right Excessive Wear & Tear | Replace |

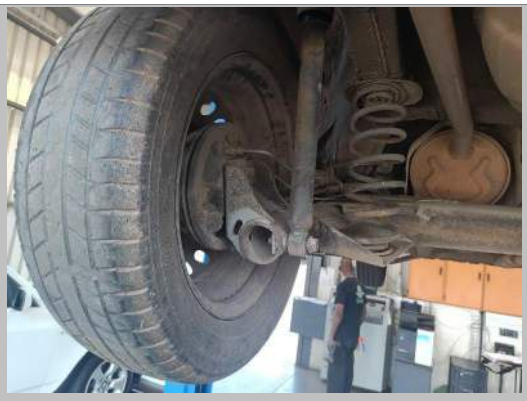
LR TYRE TREAD

| Damage | Repair Way |
|---|---|
| Tyre Rear Left Excessive Wear & Tear | Replace |

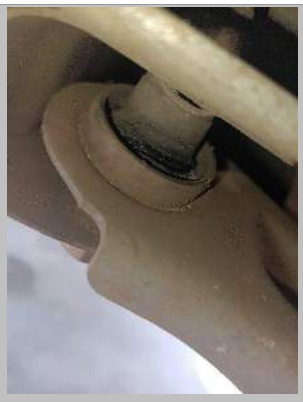
| Damage | Repair Way |
|---|---|
| Control Arm Bush(es) Front Axle Right Cracked | Replace |

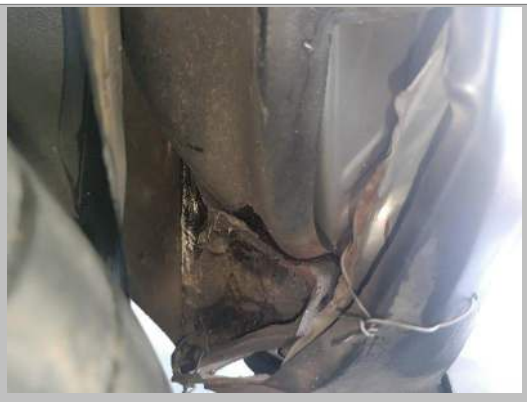
| Damage | Repair Way |
|---|---|
| Front Fender Left / Inner Tray Damaged | Repair |

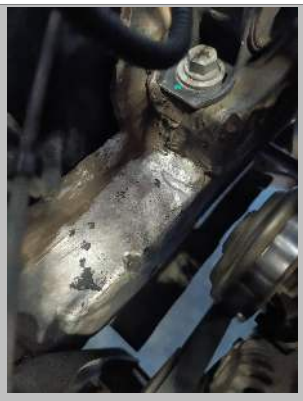
| Damage | Repair Way |
|---|---|
| Main Beam Right Residual Traces of Repair | Repair |
