# CONDITION REPORT

**Report No:**
**2017307128**
**DATE**
**03/10/2026**

| Manufacturer | RENAULT | Registration Number | LR97JNGP |
| VIN | MEEBBA00600832404 | Date Of First Licensing | |

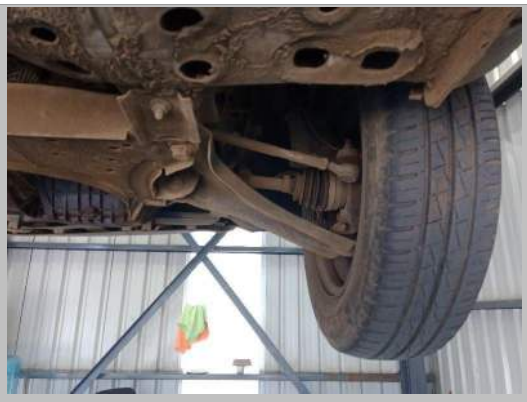
| | Size | Load/Speed Index | Manufacture | Model | Type* | Production Date | Tread Depth (mm) |
|---|---|---|---|---|---|---|---|
| **Front Left** | 165/70R14 | 81T | Ceat | Radial | V | 4822 | 1 mm |

LF TYRE TREAD

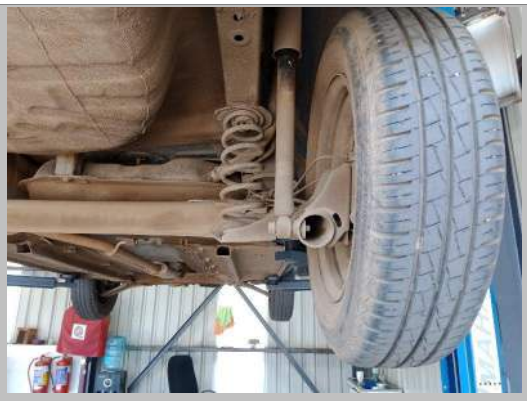
| | Size | Load/Speed Index | Manufacture | Model | Type* | Production Date | Tread Depth (mm) |
|---|---|---|---|---|---|---|---|
| **Front Right** | 165/70R14 | 81T | Ceat | Radial | V | 4722 | 1 mm |

RF TYRE TREAD

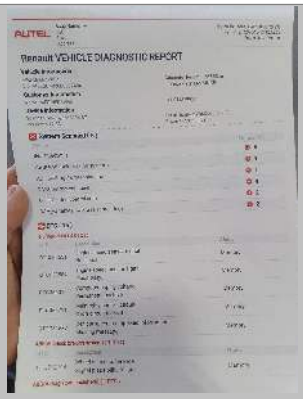
Diagnostic Report page 1

| No | System | Code | Description | Status |
|---|---|---|---|---|
| 1 | ABS (ANTI-LOCK BRAKING SYSTEM) ( 1 DTC) | DTC512764 | WHEEL SPEED COHERENCE SIGNAL PLAUSIBILITY FAILURE | |
