CONDITION REPORT

Report No:
2017323204
DATE
10/11/2026

Vehicle Type	PASSENGER VEHICLE	Registered Owner	
Manufacturer	RENAULT	Registration Number	MK14DXGP
Model	KWID	Register Number	
VIN	MEEBBA00600867086	Date Of First Licensing	
Engine Number		Last COR	
Doors	5	License Expiry Date	31/05/2027
Color	SILVER	Power / Displacement	
Year Model		Paint Finish	C - COMMON
Km Reading	14,450 KM	Fuel	PETROL
Cab / Body Type	HATCHBACK	Transmission	MANUAL

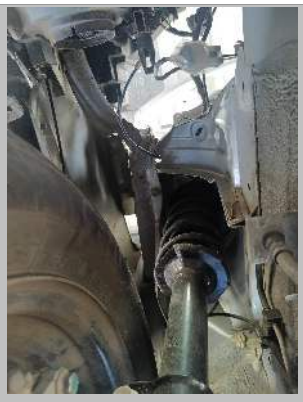
Inner Body Panel and shock mou

General Comments: ACCORDING TO THE AGE AND MILEAGE OF THE VEHICLE, NORMAL WEAR AND TEAR MARKS ARE VISIBLE ON THE INTERIOR, EXTERIOR, ELECTRICAL AND MECHANICAL PARTS.Body • Exterior: Front Right Inner Body panel damaged.(repair).Signs of impact damage to front right Corner of vehicle.
Undercarriage: FRONT LEFT SHOCK TOWER DENTED.SAFETY INTEGRITY OF VEHICLE COMPROMISED.
Road Test: Signs of vehicle crabbing.

Main Beam Right Dented	Repair
Chassis Dented	Repair
Sub Frame Damaged	Replace
CV Joint(s) Front Right (inner/outer) Damaged	Replace
Radiator Cradle Damaged	Repair
SIGNS OF FRONT AIRBAGS DEPLOYED	Replace
INNER BODY PANELS FRONT RIGHT FENDER	Repair

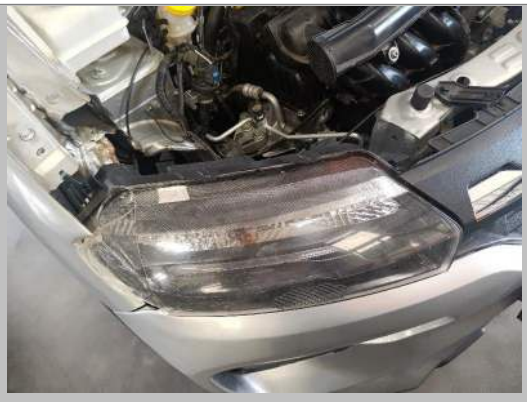
Damage	Repair Way
Wiring connections Defective	Repair
Headlight Right Damaged	Replace
Seat Belt Front Left Damaged	Replace
Seat Belt Front Right Damaged	Replace
Door Panel Front Right Defective	Repair
Door Lock Front Right Defective	Repair
Dash Padding Damaged	Repair
Steering Wheel Trim Damaged	Replace
Front Bumper Damaged	Repair
Grill Damaged	Repair
Bonnet Dented	Repair
A • Pillar Right Damaged	Repair
Front Fender Left Damaged	Repair
Front Fender Right Damaged	Repair
Rear Fender Left Dented	Repair
Rear Fender Right Damaged	Repair
Front Fender Right / Inner Tray Damaged	Replace
Door Front Left Dented	Repair
Door Front Right Damaged	Repair
Door Rear Left Dented	Repair
Door Rear Right Damaged	Repair
Boot Lid / Hatch door Dented	Repair
Rear bumper Residual Traces of Repair	Repair
Sill Panel Right Damaged	Repair
Roof Dented	Repair
Windscreen Chipped	Repair
Control Arm(s) Front Axle Right Damaged	Replace
Rim Spare Wheel Dented	Repair
