CONDITION REPORT

Report No:
2017315696
DATE
22/10/2026

Vehicle Type	PASSENGER VEHICLE	Registered Owner	
Manufacturer	RENAULT	Registration Number	JM95JZGP
Model	KWID	Register Number	
VIN	MEEBBA00700715205	Date Of First Licensing	
Engine Number		Last COR	
Doors	5	License Expiry Date	30/06/2026
Color	BLUE	Power / Displacement	
Year Model		Paint Finish	TWO COAT METALLIC
Km Reading	119,520 KM	Fuel	PETROL
Cab / Body Type	HATCHBACK	Transmission	MANUAL

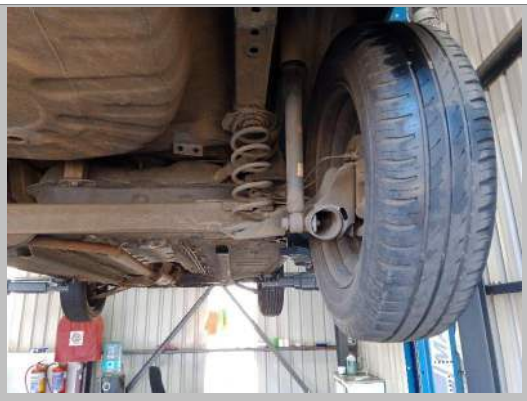
LF TYRE TREAD

Size	Load/Speed Index	Manufacture	Model	Type*	Production Date	Tread Depth (mm)
Front Left	175/65R14	82T	Continental	Contieco	V	0721	0 mm
Front Right	175/70R13	82T	Durun	Radial	V	0125	4 mm
Rear Left	165/70R14	81T	Goodyear	Assurance	V	3523	2 mm
Rear Right	175/65R14	82T	Continental	Contieco	V	0821	2 mm

Damage	Repair Way
Engine Oil Leak	Repair
Central Air Vent Damaged	Replace
Seat Front Right Damaged	Repair
Front Bumper Damaged	Repair
Bonnet Damaged	Repair
Front Fender Left Damaged	Repair
Front Fender Right Damaged	Repair
Rear Fender Left Damaged	Repair
Rear Fender Right Damaged	Repair
Door Front Left Damaged	Repair
Door Front Right Damaged	Repair
Door Rear Left Damaged	Repair
Door Rear Right Damaged	Repair
Boot Lid / Hatch door Damaged	Repair
Rear bumper Damaged	Repair
Roof Damaged	Repair
Tyre Front Left Worn	Replace
Battery loose	Repair
Rear tyres size differs	Replace
Front tyres size differs	Replace

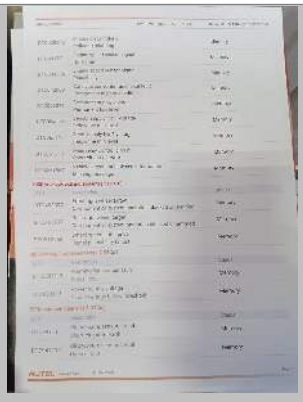
Diagnostic Report page 1

No	System	Code	Description	Status
1	INJ	DTC011517	WATER TEMPERATURE SENSOR CIRCUIT VOLTAGE TOO HIGH

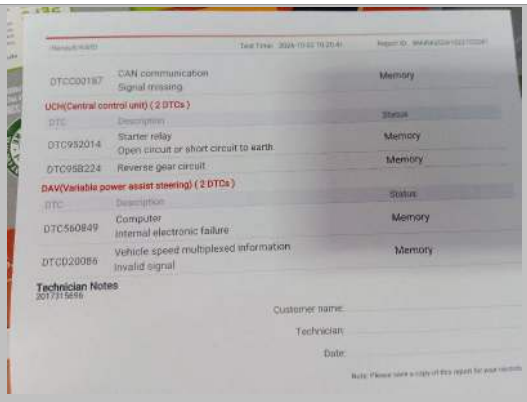
Diagnostic Report page 2

DTC	Description	Status
DTC952014	Starter relay Open circuit or short circuit to earth	Memory
DTC95B224	Reverse gear circuit	Memory

DTC	Description	Status
DTC560849	Computer Internal electronic failure	Memory
DTCD20086	Vehicle speed multiplexed information Invalid signal	Memory
