CONDITION REPORT

Report No:
2017314864
DATE
21/10/2026

Vehicle Type	PASSENGER VEHICLE	Registered Owner	MFC AUCTION HOUSE
Manufacturer	RENAULT	Registration Number	HCZ005L
Model	KWID	Register Number	
VIN	MEEBBA00900839072	Date Of First Licensing	
Engine Number		Last COR	
Doors	5	License Expiry Date	31/12/2026
Color	GREEN	Power / Displacement	
Year Model		Paint Finish	PEARL EFFECT
Km Reading	69,077 KM	Fuel	PETROL
Cab / Body Type	HATCHBACK	Transmission	AUTOMATIC

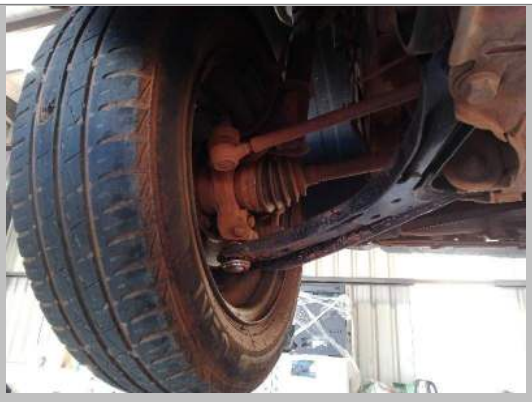
Rear bumper Damaged	Repair
Inner Boot Floor Pan and Spare Wheel Well Damaged	Repair
Sill Panel Left Damaged	Repair
Sill Panel Right Dented	Repair
Roof Dented	Repair
Service Brake Performance Rear Axle Left / Right Difference out of legal range	Repair
Shock Absorber Rear Right Sweat	Replace
Alignment Poor Alignment	Repair
Rear Axle Damaged	Repair
Ball Joint(s) Front Axle Right Loose / Excessive Play	Repair
Tyre Front Left Damaged	Replace
Tyre Front Right Worn	Replace
Tyre Rear Left Damaged	Replace
Tyre Rear Right Torn / Cut	Replace
Spare Tyre Damaged	Replace
Rim Rear Left Dented	Repair
Rim Spare Wheel Dented	Repair
Chassis Damaged	Repair
Sub Frame Damaged	Replace
Silencer Damaged	Replace
Fuel Lines Defective	Repair
Radiator Cradle Damaged	Replace
Engine Noise Excessive	Repair
Jack Missing	Replace
Wheel Spanner Missing	Replace
Airbag warning light illuminated on dashboard	Repair
Flywheel dust cover damaged	Replace
Engine cover damaged	Replace

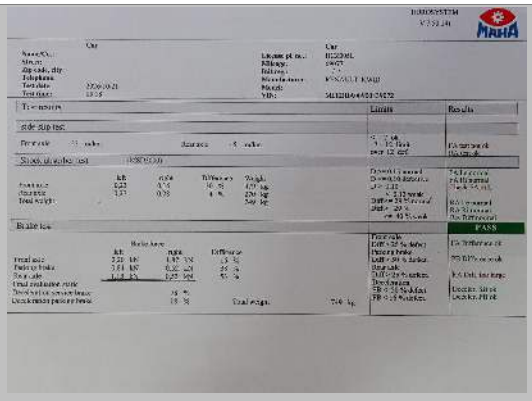
Damage	Repair Way
Engine Oil Leak	Repair
Interior Lights Defective	Repair
Indicator Light Front Left Damaged	Replace
Indicator Light Front Right Damaged	Replace
Seat Front Left Dirty	Repair
Seat Front Right Dirty	Repair
Seat Rear Dirty	Repair
Hood Lining Dirty	Repair
Door Sealing Rubber Front Right Damaged	Replace
Door Sealing Rubber Rear Left Damaged	Replace
Parcel Tray Missing	Replace
Boot Carpet Damaged	Replace
Steering Wheel Trim Excessive Wear & Tear	Repair
Side Mirror Left Paintwork • Scratched	Repair
Front Bumper Damaged	Repair
Bonnet Dented	Repair
C • Pillar Right Paintwork • Scratched	Repair
Front Fender Left Damaged	Repair
Front Fender Right Damaged	Repair
Rear Fender Left Damaged	Repair
Front Fender Right / Inner Tray Damaged	Repair
Door Front Left Damaged	Repair
Door Rear Left Damaged	Repair
Door Rear Right Dented	Repair
Boot Lid / Hatch door Damaged	Repair
Boot Lid / Hatch Door Rubbers Damaged	Replace
