CONDITION REPORT

Report No:
2017317275
DATE
26/10/2026

Vehicle Type	PASSENGER VEHICLE	Registered Owner	MFC
Manufacturer	RENAULT	Registration Number	LCW020MP
Model	KIGER	Register Number	
VIN	MEEHBC00000113963	Date Of First Licensing	
Engine Number		Last COR	
Doors	5	License Expiry Date	31/08/2027
Color	WHITE	Power / Displacement	
Year Model		Paint Finish	C - COMMON
Km Reading	35,892 KM	Fuel	PETROL
Cab / Body Type	HATCHBACK	Transmission	AUTOMATIC

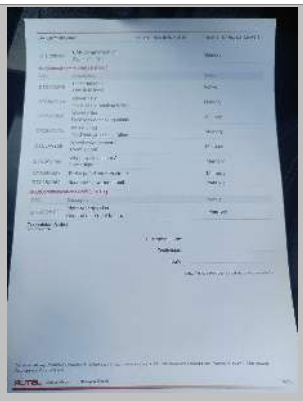
Diagnostics

No	System	Code	Description	Status
1	INJ(INJECTION)	DTC0226F1	BRAKE/ACCELERATION PEDAL POSITION SAFETY MODE 1 FLAG

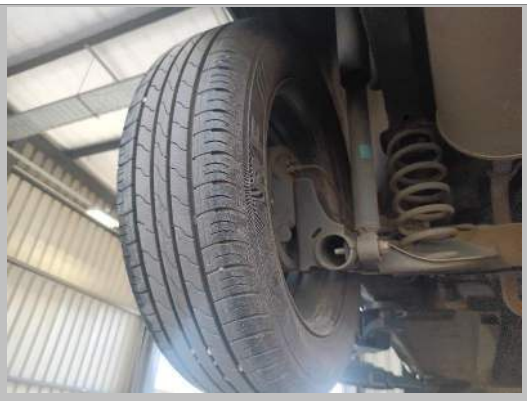
LF TYRE TREAD

Size	Load/Speed Index	Manufacture	Model	Type*	Production Date	Tread Depth (mm)
Front Left	195/60R16	89H	MRF	WANDERER	V	1724	3 mm
Front Right	195/60R16	89H	MRF	Wanderer	V	1624	2 mm
Rear Left	195/60R16	89H	MRF	WANDERER	V	1624	4 mm
Rear Right	195/60R16	89H	WESTLAKE	ZUPERECO	V	5024	4 mm
Spare	165/80R14	85R	CEAT	TEMPORARY	V	0000	3 mm

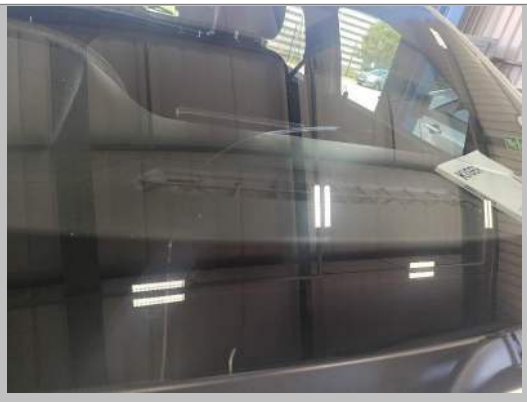
Damage	Repair Way
Front Bumper Paintwork • Scratched	Repair
Bonnet Dented	Repair
Front Fender Right Residual Traces of Repair	Repair
Rear Fender Right Paintwork • Chipmarks	Repair
Door Front Right Dented	Repair
Door Rear Right Dented	Repair
Sill Panel Left Paintwork • Scratched	Repair
Windscreen Cracked	Replace
Service Brake Performance Rear Axle Insufficient	Repair
Tyre Front Right Damaged	Replace
Gear Selections Slippy Hesitation	Repair
Warning light illuminated	Repair
