CONDITION REPORT

Report No:
2017309873
DATE
09/10/2026

MFC Auction House
M57 Pretoria Rd, Glenmarais, KEMPTON PARK
Gauteng

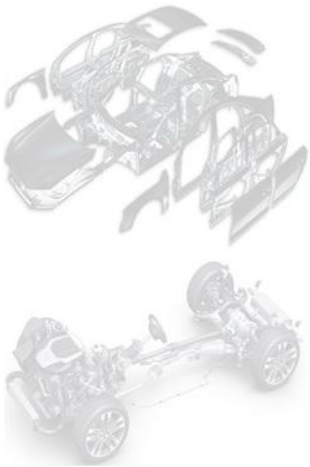
VEHICLE INSPECTION

Damage	Repair Way
Headlight Left Damaged	Replace
Front Bumper Damaged	Repair
Bonnet Damaged	Repair
Front Fender Left Damaged	Repair
Door Front Left Damaged	Repair
Door Rear Left Damaged	Repair
Door Rear Right Damaged	Repair
Boot Lid / Hatch door Damaged	Repair
Window Rear Door Right Damaged	Replace
Sealing Window Rear Door Left Damaged	Repair
Control Arm(s) Front Axle Right Damaged	Replace
Tyre Front Left Worn	Replace
Rim Front Right Damaged	Replace

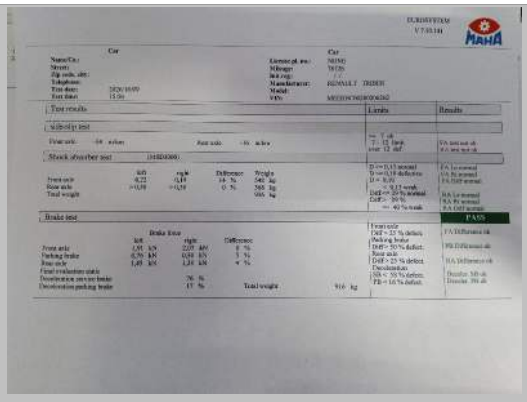
Brake test.

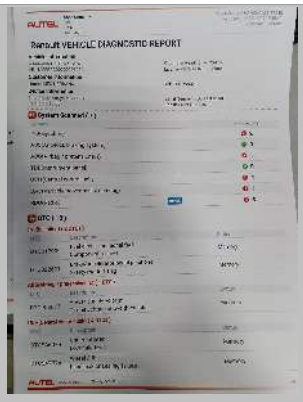
During the diagnostic no active error messages were detected. (See also attached Diagnostic Report. For more information regarding the Fault Codes (DTC) and the recommended rectifications please contact the workshops of the vehicle manufacture).

Diagnostic.

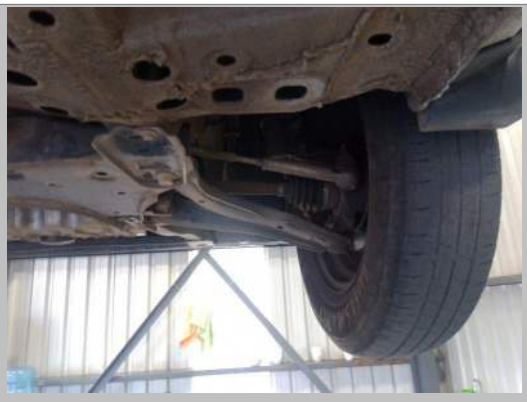
RR TYRE TREAD

Size	Load/Speed Index	Manufacture	Model	Type*	Production Date	Tread Depth (mm)
Front Left	165/80R14	85T	Ceat	Radial	V	1924	0 mm
Front Right	165/80R14	85T	Ceat	Radial	V	1924	1 mm
Rear Left	165/80R14	85T	Ceat	Radial	V	1924	2 mm
Rear Right	165/80R14	85T	Ceat	Radial	V	1924	2 mm
Spare	165/80R14	85R	Ceat	Radial	V	1724	2 mm
