CONDITION REPORT

Report No:
2017306227
DATE
02/10/2026

Vehicle Type	PASSENGER VEHICLE	Registered Owner	
Manufacturer	RENAULT	Registration Number	LY31YJGP
Model	TRIBER	Register Number	
VIN	MEERBC00300208554	Date Of First Licensing	
Engine Number		Last COR	
Doors	5	License Expiry Date	30/06/2027
Color	WHITE	Power / Displacement	
Year Model		Paint Finish	C - COMMON
Km Reading	90,808 KM	Fuel	PETROL
Cab / Body Type	HATCHBACK	Transmission	MANUAL

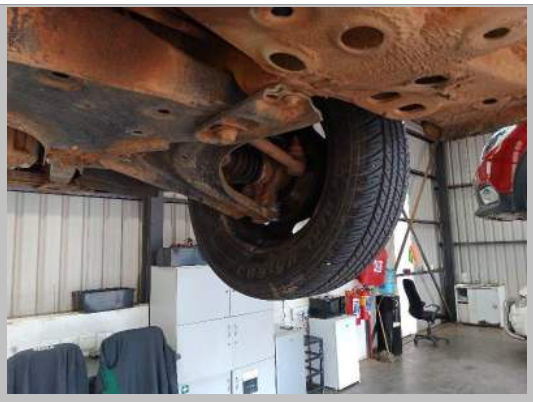
LF TYRE TREAD

Size	Load/Speed Index	Manufacture	Model	Type*	Production Date	Tread Depth (mm)
Front Left	185/60R14	82H	Ling long	Crosswind	V	1523	4 mm
Front Right	185/60R14	82H	Maxxis	Radial	V	3509	3 mm
Rear Left	185/60R14	82H	Setula	Ever shine	V	3822	3 mm
Rear Right	185/60R14	82H	King Boss	G521	V	3222	3 mm

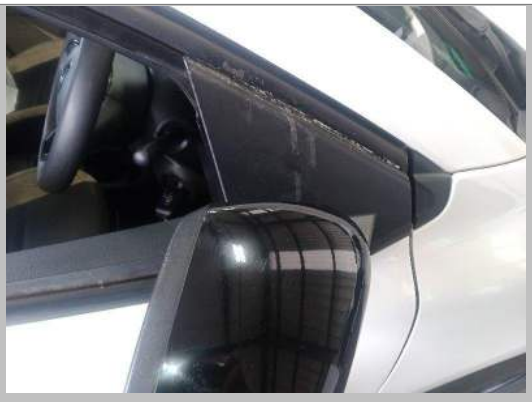
Damage	Repair Way
Side Mirror Left Damaged	Repair
Side Mirror Right Damaged	Repair
Front Bumper Paintwork • Scratched	Repair
Bonnet Paintwork • Chipmarks	Repair
Front Fender Left Residual Traces of Repair	Repair
Rear Fender Left Dented	Repair
Rear Fender Right Dented	Repair
Door Front Left Paintwork • Scratched	Repair
Door Front Right Paintwork • Chipmarks	Repair
Door Rear Left Paintwork • Scratched	Repair
Door Rear Right Paintwork • Chipmarks	Repair
Boot Lid / Hatch door Dented	Repair
Rear bumper Paintwork • Scratched	Repair
All four hup caps missing	Replace
