CONDITION REPORT

Report No:
2017306881
DATE
02/10/2026

Vehicle Type	PASSENGER VEHICLE	Registered Owner	MFC
Manufacturer	RENAULT	Registration Number	LF98XMGP
Model	TRIBER	Register Number	
VIN	MEERBC00500163830	Date Of First Licensing	
Engine Number		Last COR	
Doors	5	License Expiry Date	31/07/2027
Color	BROWN	Power / Displacement	
Year Model		Paint Finish	TWO COAT METALLIC
Km Reading	66,768 KM	Fuel	PETROL
Cab / Body Type	HATCHBACK	Transmission	MANUAL

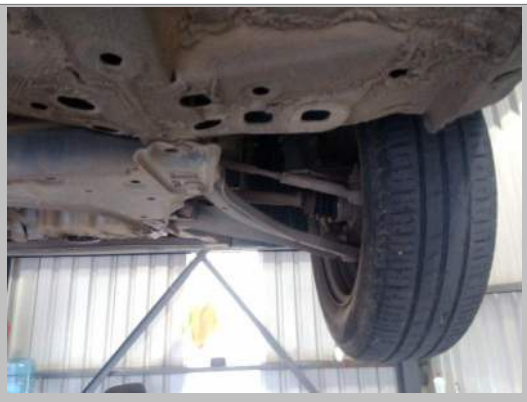
LF TYRE TREAD

Size	Load/Speed Index	Manufacture	Model	Type*	Production Date	Tread Depth (mm)
Front Left	185/65R15	88H	Ceat	Radial	V	4622	0 mm
Front Right	185/65R15	88H	Ceta	Radial	V	4622	0 mm
Rear Left	185/65R15	88H	Ceat	Radial	V	4622	0 mm
Rear Right	185/65R15	88H	Ceat	Radial	V	4622	1 mm
Spare	185/65R15	88H	Dayton	Radial	V	0000	0 mm

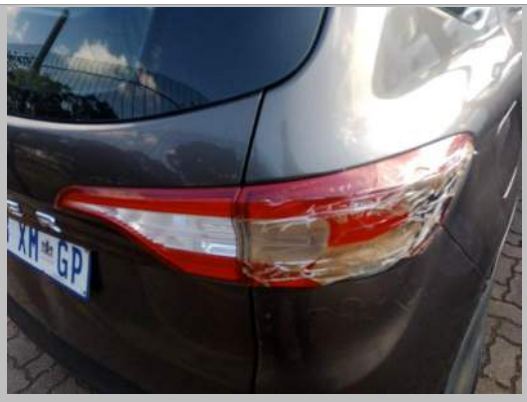
Damage	Repair Way
Engine Oil Leak	Repair
Radio/CD/USB Damaged	Replace
Engine Management Lights Set	Replace
Tail Light Left Damaged	Repair
Tail Light Right Damaged	Repair
Seat Front Right Damaged	Repair
Seat Rear (2. Row) Damaged	Repair
Side Mirror Left Damaged	Replace
Side Mirror Right Damaged	Replace
Front Bumper Damaged	Repair
Bonnet Damaged	Repair
Front Fender Left Damaged	Repair
Front Fender Right Damaged	Replace
Rear Fender Left Damaged	Repair
Rear Fender Right Damaged	Repair
Door Front Left Damaged	Repair
Door Front Right Damaged	Repair
Door Rear Left Damaged	Repair
Door Rear Right Damaged	Repair
Boot Lid / Hatch door Damaged	Repair
Rear bumper Defective	Repair
Tyre Front Left Worn	Replace
Tyre Front Right Worn	Replace
Tyre Rear Left Worn	Replace
Spare Tyre Worn	Replace

Seat Front Right
