CONDITION REPORT

Report No:
2017309928
DATE
12/10/2026

Vehicle Type	PASSENGER VEHICLE	Registered Owner	MFC
Manufacturer	RENAULT	Registration Number	HDZ771L
Model	TRIBER	Register Number	
VIN	MEERBC00600182967	Date Of First Licensing	
Engine Number		Last COR	
Doors	5	License Expiry Date	31/03/2027
Color	BLUE	Power / Displacement	
Year Model		Paint Finish	M - METALLIC
Km Reading	18,406 KM	Fuel	PETROL
Cab / Body Type	HATCHBACK	Transmission	MANUAL

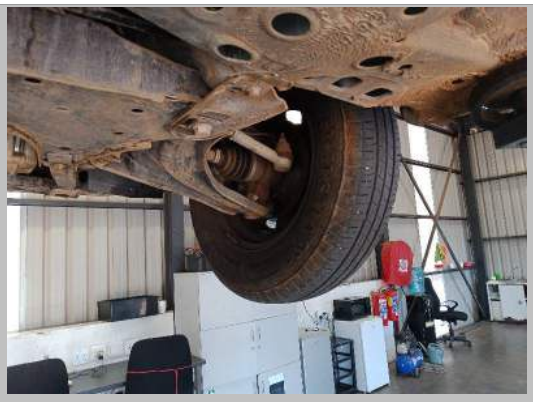
LR TYRE TREAD

Size	Load/Speed Index	Manufacture	Model	Type*	Production Date	Tread Depth (mm)
Front Left	165/80R14	85T	Ceat	Fuel smart	V	1923	3 mm
Front Right	165/80R14	85T	Ceat	Fuel smart	V	1923	3 mm
Rear Left	165/80R14	85T	Ceat	Fuel smart	V	1923	3 mm
Rear Right	165/80R14	85T	Ceat	Fuel smart	V	1923	3 mm
Spare	165/80R14	85R	Ceat	Stepnee	V	1223	4 mm

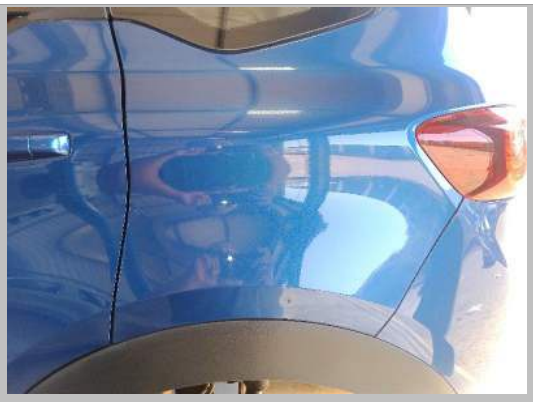
Damage	Repair Way
Front Bumper Paintwork • Scratched	Repair
Bonnet Paintwork • Scratched	Repair
Front Fender Left Paintwork • Scratched	Repair
Front Fender Right Paintwork • Scratched	Repair
Rear Fender Left Dented	Repair
Rear Fender Right Paintwork • Scratched	Repair
Door Front Left Paintwork • Scratched	Repair
Door Front Right Paintwork • Scratched	Repair
Door Rear Left Paintwork • Scratched	Repair
Door Rear Right Paintwork • Scratched	Repair
