# CONDITION REPORT

**Report No:**
**2017311896**
**DATE**
**14/10/2026**

| Manufacturer | HYUNDAI | Registration Number | MK62RLGP |
| Model | CRETA | Register Number | |

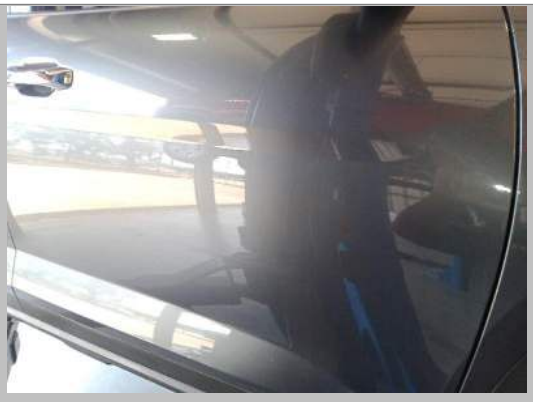
| Damage | Repair Way |
|---|---|
| Door Rear Right Paintwork • Scratched | Repair |
