# CONDITION REPORT

**Report No:**
**2017309875**
**DATE**
**09/10/2026**

| Manufacturer | TOYOTA | Registration Number | NF39YPGP |
| Model | AGYA 1.0 5-DR [2020-2023] | Register Number | |

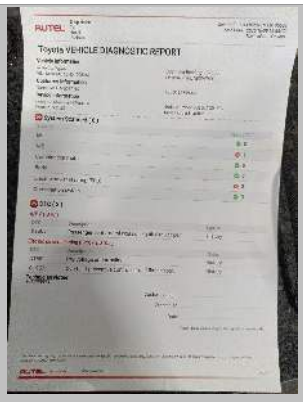
Diagnostics report

| No | System | Code | Description | Status |
|---|---|---|---|---|
| 1 | AIRBAG | B1806 | PASSENGER SEAT FRONTAL COLLISION SQUIB CIRCUIT OPEN CIRCUIT | |

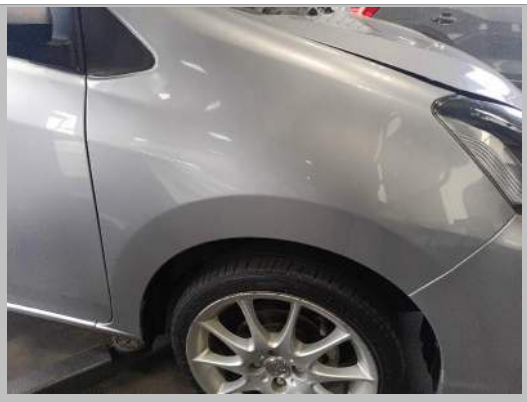
| Damage | Repair Way |
|---|---|
| Front Fender Right Residual Traces of Repair | Repair |
