CONDITION REPORT

Report No:
2017317764
DATE
27/10/2026

Vehicle Type	PASSENGER VEHICLE	Registered Owner	MFC AUCTION HOUSE
Manufacturer	TOYOTA	Registration Number	JXB158MP
Model	AVANZA	Register Number	
VIN	MHKM5EA1N0K002888	Date Of First Licensing	
Engine Number		Last COR	
Doors	5	License Expiry Date	30/04/2025
Color	GOLDEN	Power / Displacement	
Year Model		Paint Finish	TWO COAT METALLIC
Km Reading	260,172 KM	Fuel	PETROL
Cab / Body Type	STATION WAGON	Transmission	MANUAL

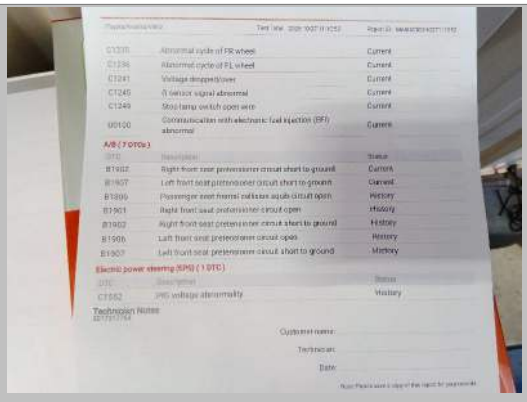
Diagnostic.

No	System	Code	Description	Status
1	EFI	P0014	EXHAUST DUAL VARIABLE VALVE TIMING ADVANCE FAULT

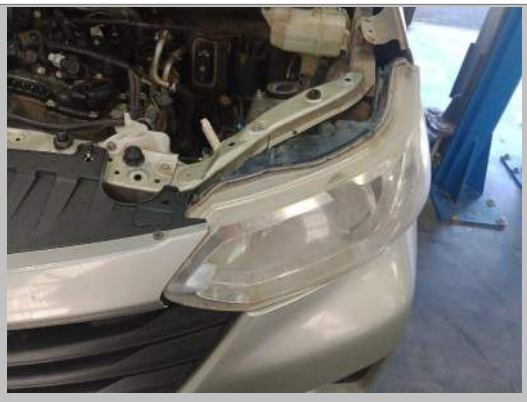
Damage	Repair Way
Engine Oil Leak	Repair
Central Air Vent Damaged	Replace
Engine Management Lights Set	Repair
Tail Light Left Damaged	Replace
Tail Light Right Damaged	Repair
Headlight Left Damaged	Replace
Headlight Right Damaged	Replace
Seat Front Left Damaged	Repair
Seat Front Right Damaged	Repair
Seat Rear Damaged	Replace
Seat Rear (2. Row) Damaged	Repair
Steering Wheel Trim Damaged	Repair
Front Bumper Damaged	Repair
Bonnet Damaged	Repair
Bonnet slam plate (Shock tower/ Inner tray) Damaged	Replace
Front Fender Left Damaged	Repair
Front Fender Right Damaged	Repair
Rear Fender Left Damaged	Repair
Rear Fender Right Damaged	Repair
Door Front Left Damaged	Repair
Door Front Right Damaged	Repair
Door Rear Left Damaged	Repair
Door Rear Right Damaged	Repair
Boot Lid / Hatch door Damaged	Repair
Rear bumper Damaged	Repair
Brake disc 1. Axle left Damaged	Replace
Brake disc 1. Axle right Damaged	Replace
Parking Brake Performance Insufficient	Repair

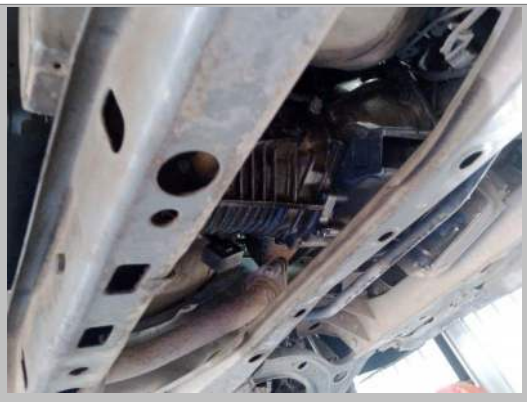
Control Arm Bush(es) Front Axle Left Worn	Replace
Control Arm Bush(es) Front Axle Right Worn	Replace
Mounting Rubber(s) Rear Axle Left Worn	Replace
Mounting Rubber(s) Rear Axle Right Worn	Replace
Tyre Front Left Worn	Replace
Tyre Front Right Worn	Replace
Tyre Rear Left Worn	Replace
Gearbox Oil Leak	Repair
Engine Performance Insufficient	Repair
Engine Noise Excessive	Repair

Size	Load/Speed Index	Manufacture	Model	Type*	Production Date	Tread Depth (mm)
Front Left	185/70R14	88H	Vanza	Radio	V	4323	0 mm
Front Right	175/65R14	82T	Velocity	Radial	V	4816	0 mm
Rear Left	185/60R14	82H	Sava	Radial	V	0316	0 mm
Rear Right	175/65R14	82T	Continental	Contieco	V	3215	1 mm
