CONDITION REPORT

Report No:
2017325982
DATE
17/11/2026

Vehicle Type	PASSENGER VEHICLE	Registered Owner	MFC AUCTION HOUSE
Manufacturer	MITSUBISHI	Registration Number	KVH976MP
Model	X-PANDER	Register Number	
VIN	MK2LRNC1WNN016672	Date Of First Licensing	
Engine Number		Last COR	
Doors	5	License Expiry Date	30/04/2027
Color	GREY	Power / Displacement	
Year Model		Paint Finish	TWO COAT METALLIC
Km Reading	117,359 KM	Fuel	PETROL
Cab / Body Type	STATION WAGON	Transmission	AUTOMATIC

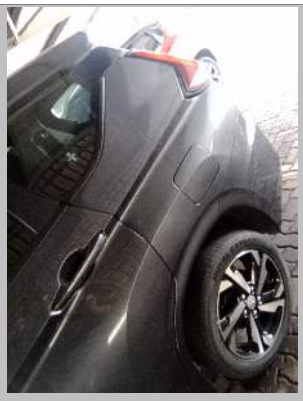
Damage	Repair Way
Seat Front Right Worn	Repair
Sun Visor Right Damaged	Repair
Front Bumper Damaged	Repair
Bonnet Damaged	Repair
Front Fender Left Damaged	Repair
Front Fender Right Damaged	Repair
Rear Fender Left Damaged	Repair
Rear Fender Right Damaged	Repair
Door Front Left Damaged	Repair
Door Front Right Damaged	Repair
Door Rear Left Damaged	Repair
Door Rear Right Damaged	Repair
Boot Lid / Hatch door Damaged	Repair
Rear bumper Damaged	Repair
Windscreen Damaged	Replace
Tyre Front Right Worn	Replace
Radiator Cradle Damaged	Replace

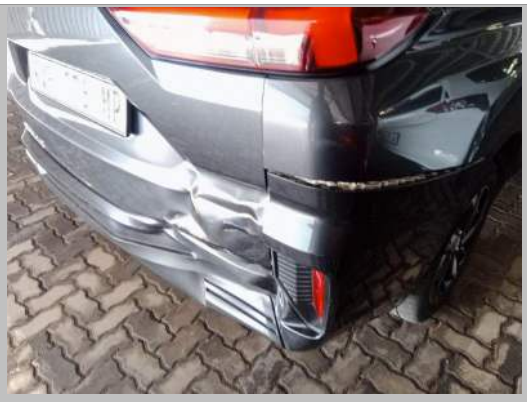
Rear bumper

General Comments: ACCORDING TO THE AGE AND MILEAGE OF THE VEHICLE, NORMAL WEAR AND TEAR MARKS ARE VISIBLE ON THE INTERIOR, EXTERIOR, ELECTRICAL AND MECHANICAL PARTS.Body • Exterior: Minor dents and scratches and stone chips to body panels. Signs of repair work done to body panels. Poor alignment to somebody panels. Signs of impact damage to rear of vehicle.
