CONDITION REPORT

Report No:
2017309251
DATE
08/10/2026

Vehicle Type	PASSENGER VEHICLE	Registered Owner	MFC
Manufacturer	KIA	Registration Number	JT00CYGP
Model	SONET	Register Number	
VIN	MZBER814MLN122401	Date Of First Licensing	
Engine Number		Last COR	
Doors	5	License Expiry Date	30/11/2027
Color	RED	Power / Displacement	
Year Model		Paint Finish	TWO COAT METALLIC
Km Reading	121,543 KM	Fuel	PETROL
Cab / Body Type	HATCHBACK	Transmission	AUTOMATIC

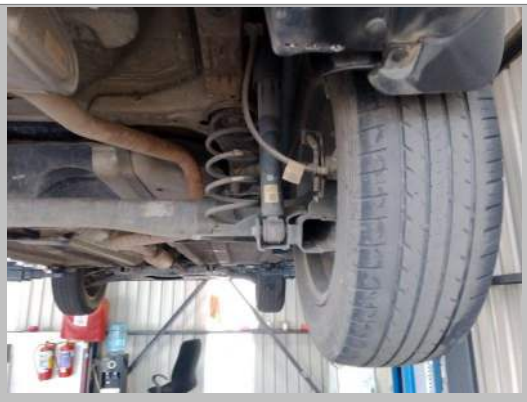
RF TYRE TREAD

Size	Load/Speed Index	Manufacture	Model	Type*	Production Date	Tread Depth (mm)
Front Left	215/65R17	99V	Michelin	Radial	V	3121	0 mm
Front Right	215/65R17	99V	Michelin	Radial	V	3121	0 mm
Rear Left	215/60R17	96H	Goodyear	Assurance	V	2120	1 mm
Rear Right	215/60R17	96H	Goodyear	Assurance	V	2120	2 mm

Damage	Repair Way
Seat Front Right Damaged	Repair
Front Bumper Damaged	Repair
Bonnet Damaged	Repair
Front Fender Left Damaged	Repair
Front Fender Right Damaged	Repair
Rear Fender Left Damaged	Repair
Rear Fender Right Damaged	Repair
Door Front Left Damaged	Repair
Door Front Right Damaged	Repair
Door Rear Left Damaged	Repair
Door Rear Right Damaged	Repair
Boot Lid / Hatch door Damaged	Repair
Rear bumper Damaged	Repair
Windscreen Damaged	Replace
Tyre Front Left Worn	Replace
Tyre Front Right Worn	Replace
Spare Tyre Defective	Replace
