CONDITION REPORT

Report No:
2017309594
DATE
08/10/2026

Vehicle Type	LIGHT LOAD VEHICLE	Registered Owner	MFC
Manufacturer	KIA	Registration Number	JW45SNGP
Model	SELTOS	Register Number	
VIN	MZBER814MMN177103	Date Of First Licensing	
Engine Number		Last COR	
Doors	5	License Expiry Date	
Color	WHITE	Power / Displacement	
Year Model		Paint Finish	TWO COAT UNI
Km Reading	59,096 KM	Fuel	PETROL
Cab / Body Type	HATCHBACK	Transmission	AUTOMATIC

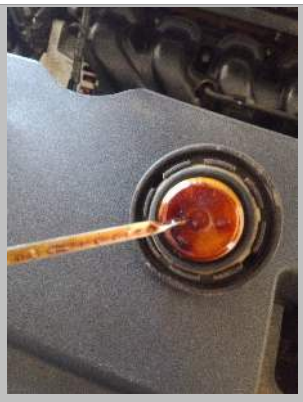
ENGINE 1

Oil cap and dipstick.

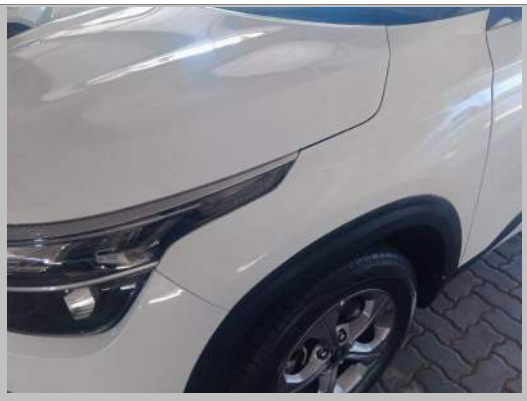
Damage	Repair Way
Seat Front Right Damaged	Repair
Seat Rear Damaged	Repair
Front Bumper Damaged	Repair
Bonnet Damaged	Repair
Front Fender Left Damaged	Repair
Front Fender Right Damaged	Repair
Rear Fender Right Damaged	Repair
Door Front Right Damaged	Repair
Door Rear Left Damaged	Repair
Door Rear Right Damaged	Repair
Roof Damaged	Repair
