CONDITION REPORT

Report No:
2017315985
DATE
22/10/2026

Vehicle Type	PASSENGER VEHICLE	Registered Owner	MFC AUCTION HOUSE
Manufacturer	KIA	Registration Number	KV19TVGP
Model	SELTOS	Register Number	
VIN	MZBET811VLN103403	Date Of First Licensing	
Engine Number		Last COR	
Doors	5	License Expiry Date	
Color	ORANGE	Power / Displacement	
Year Model		Paint Finish	M - METALLIC
Km Reading	75,931 KM	Fuel	PETROL
Cab / Body Type	HATCHBACK	Transmission	AUTOMATIC

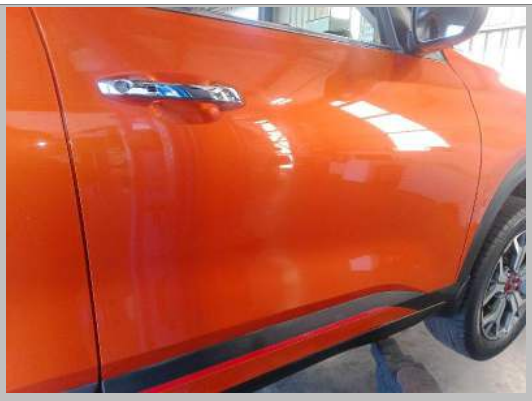
Damage	Repair Way
Front Bumper Paintwork • Scratched	Repair
Front Fender Left Dented	Repair
Front Fender Right Dented	Repair
Rear Fender Left Paintwork • Scratched	Repair
Door Front Left Paintwork • Scratched	Repair
Door Front Right Dented	Repair
Door Rear Left Paintwork • Scratched	Repair
Door Rear Right Paintwork • Scratched	Repair
Boot Lid / Hatch door Dented	Repair
Rear bumper Paintwork • Scratched	Repair
