CONDITION REPORT

Report No:
2017309820
DATE
09/10/2026

Vehicle Type	PASSENGER VEHICLE	Registered Owner	MFC
Manufacturer	KIA	Registration Number	MC40ZXGP
Model	SONET	Register Number	
VIN	MZBFB814TRN472755	Date Of First Licensing	
Engine Number		Last COR	
Doors	5	License Expiry Date	
Color	WHITE	Power / Displacement	
Year Model		Paint Finish	TWO COAT UNI
Km Reading	32,938 KM	Fuel	PETROL
Cab / Body Type	HATCHBACK	Transmission	AUTOMATIC

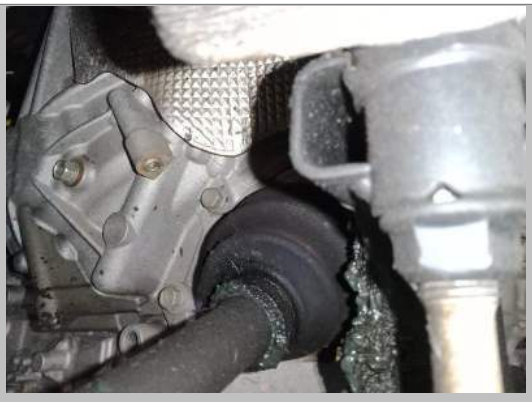
Damage	Repair Way
Seat Front Left Dirty	Repair
Bonnet Paintwork • Chipmarks	Repair
Door Front Left Dented	Repair
Control Arm Bush(es) Front Axle Left Damaged	Replace
