CONDITION REPORT

Report No:
2017315654
DATE
22/10/2026

MFC Auction House
M57 Pretoria Rd, Glenmarais, KEMPTON PARK
Gauteng

Vehicle Type	PASSENGER VEHICLE	Registered Owner	
Manufacturer	KIA	Registration Number	HMP484L
Model	SONET	Register Number	
VIN	MZBFB814TTN556623	Date Of First Licensing	
Engine Number		Last COR	
Doors	5	License Expiry Date	31/10/2026
Color	GREEN	Power / Displacement	
Year Model		Paint Finish	M - METALLIC
Km Reading	13,695 KM	Fuel	PETROL
Cab / Body Type	HATCHBACK	Transmission	AUTOMATIC

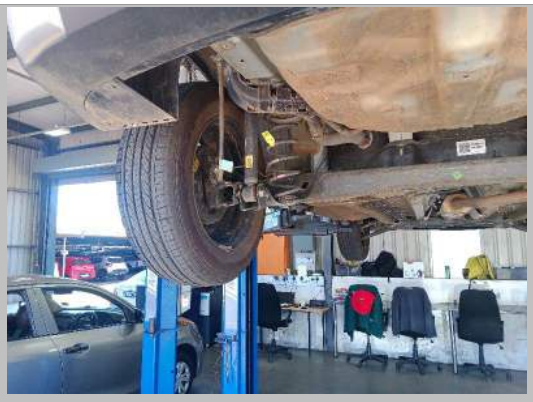
LF TYRE TREAD

Size	Load/Speed Index	Manufacture	Model	Type*	Production Date	Tread Depth (mm)
Front Left	195/65R15	91H	Goodyear	Assurance	V	2625	3 mm
Front Right	195/65R15	91H	Goodyear	Assurance	V	2725	3 mm
Rear Left	195/65R15	91H	Goodyear	Assurance	V	2625	3 mm
Rear Right	195/65R15	91H	Goodyear	Assurance	V	2725	3 mm
Spare	195/65R15	91H	Goodyear	Assurance	V	2725	5 mm

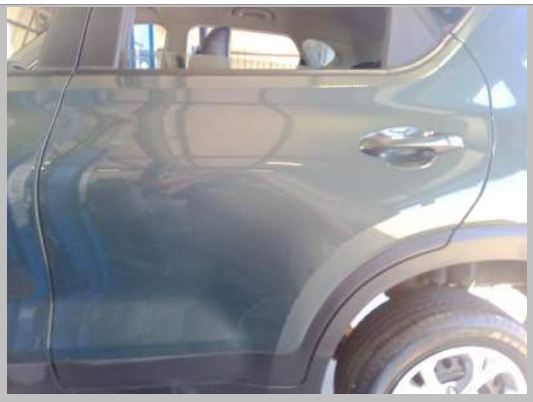
Damage	Repair Way
Water level Insufficient	Repair
Front Bumper Paintwork • Chipmarks	Repair
Bonnet Paintwork • Chipmarks	Repair
Rear Fender Right Paintwork • Scratched	Repair
Door Front Right Paintwork • Chipmarks	Repair
Door Rear Left Paintwork • Scratched	Repair
Door Rear Right Paintwork • Scratched	Repair
