CONDITION REPORT

Report No:
2017318137
DATE
27/10/2026

Vehicle Type	PASSENGER VEHICLE	Registered Owner	
Manufacturer	JAGUAR	Registration Number	LT75XTGP
Model	E-PACE 2.0 R-DYNAMIC 132KW (D180) SE DSL AWD AT [2019-2021]	Register Number	
		Date Of First Licensing	
VIN	SADFA2AN3K1Z72044	Last COR	
Engine Number		License Expiry Date	
Doors	5	Power / Displacement	
Color	BLUE	Paint Finish	M - METALLIC
Year Model	2020	Fuel	DIESEL
Km Reading	80,527 KM	Transmission	AUTOMATIC
Cab / Body Type	STATION WAGON

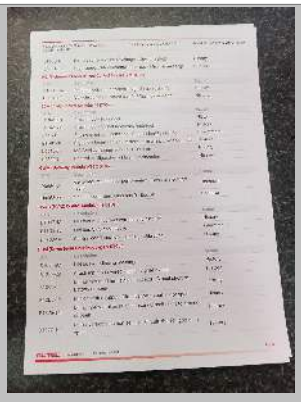
Diagnostic report

No	System	Code	Description	Status
1	HISTORY	B10A2-38	CRASH INPUT -SIGNAL FREQUENCY INCORRECT

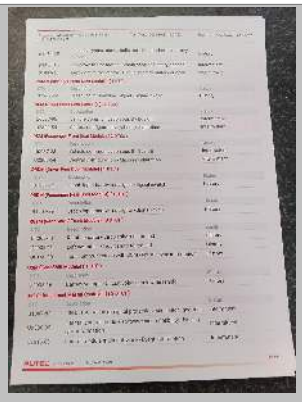
During the diagnostic the following error messages were detected: (See also attached Diagnostic Report. For more information regarding the Fault Codes (DTC) and the recommended rectifications please contact the workshops of the vehicle manufacture).

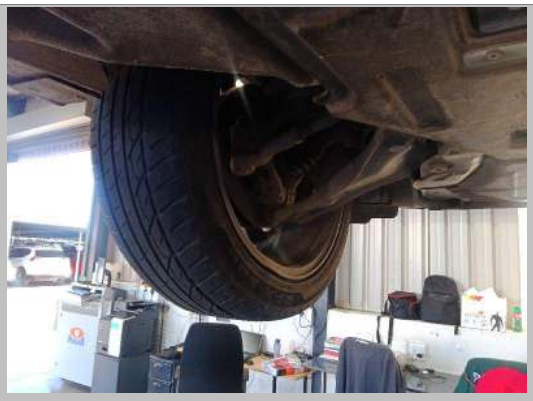
LF TYRE TREAD

Size	Load/Speed Index	Manufacture	Model	Type*	Production Date	Tread Depth (mm)
Front Left	245/45R20	103W	Rovelo	RPX-988	V	1922	3 mm
Front Right	245/45R20	103W	Rovelo	RPX-988	V	1922	3 mm
Rear Left	245/45R20	103W	Rovelo	Rpx-988	V	1922	3 mm
Rear Right	245/45R20	103W	Rovelo	RPX-988	V	1922	3 mm
Spare	T155/85R18	115M	Pirelli	Temporary	V	5118	4 mm
