CONDITION REPORT

Report No:
2017318687
DATE
28/10/2026

Vehicle Type	PASSENGER VEHICLE	Registered Owner	MFC AUCTION HOUSE
Manufacturer	NISSAN	Registration Number	KWC608MP
Model	QASHQAI 1.5 DCI ACENTA DSL 5-DR [2014-2018]	Register Number	
		Date Of First Licensing	
VIN	SJNFAAJ11Z1780422	Last COR	
Engine Number		License Expiry Date	31/08/2025
Doors	5	Power / Displacement	
Color	WHITE	Paint Finish	TWO COAT UNI
Year Model	2016	Fuel	DIESEL
Km Reading	162,349 KM	Transmission	MANUAL
Cab / Body Type	SUV

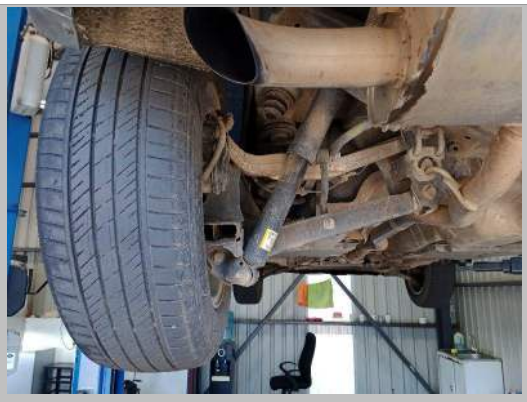
LF TYRE TREAD

Size	Load/Speed Index	Manufacture	Model	Type*	Production Date	Tread Depth (mm)
Front Left	215/60R17	96H	Dunlop	EC300	V	3318	0 mm
Front Right	215/60R17	96H	Dunlop	EC300	V	3318	0 mm
Rear Left	215/60R17	96H	Kumho	Radial	V	4622	0 mm
Rear Right	215/60R17	96T	Sailun	Radial	V	2324	0 mm

Damage	Repair Way
Engine Oil Leak	Repair
Engine Management Lights Set	Repair
Seat Front Left Damaged	Repair
Seat Front Right Damaged	Repair
Hood Lining Damaged	Repair
Front Bumper Damaged	Repair
Bonnet Damaged	Repair
Front Fender Left Damaged	Repair
Front Fender Right Damaged	Repair
Rear Fender Left Damaged	Repair
Rear Fender Right Damaged	Repair
Door Front Left Damaged	Repair
Door Front Right Damaged	Repair
Door Rear Left Damaged	Repair
Rear bumper Damaged	Repair
Windscreen Damaged	Replace
Tyre Front Left Worn	Replace
Tyre Front Right Worn	Replace
Tyre Rear Left Worn	Replace
Tyre Rear Right Worn	Replace
Rim Front Right Damaged	Replace
Warning light illuminated	Repair

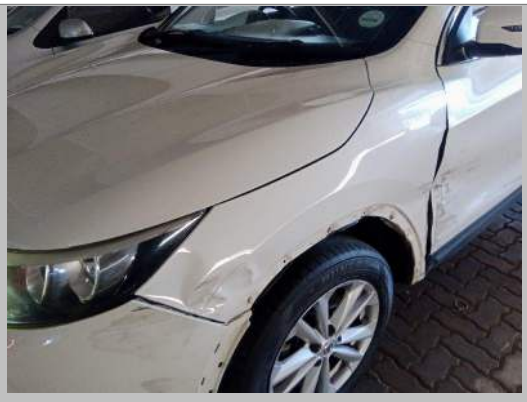
Bonnet

General Comments: ACCORDING TO THE AGE AND MILEAGE OF THE VEHICLE, NORMAL WEAR AND TEAR MARKS ARE VISIBLE ON THE INTERIOR, EXTERIOR, ELECTRICAL AND MECHANICAL PARTS.SIGNS OF REPAIR WORK DONE TO BODY PANELS. POOR ALIGNMENT TO SOMEBODY PANELS. SIGNS OF AIRBAGS DEPLOYED ON LEFT SIDE OF VEHICLE.
