CONDITION REPORT

Report No:
2017314858
DATE
21/10/2026

Vehicle Type	PASSENGER VEHICLE	Registered Owner	MFC AUCTION HOUSE
Manufacturer	RENAULT	Registration Number	LDL926NW
Model	CAPTUR	Register Number	
VIN	VF12R051564196186	Date Of First Licensing	
Engine Number		Last COR	
Doors	5	License Expiry Date	31/12/2026
Color	BEIGE	Power / Displacement	
Year Model		Paint Finish	C - COMMON
Km Reading	188,071 KM	Fuel	PETROL
Cab / Body Type	HATCHBACK	Transmission	MANUAL

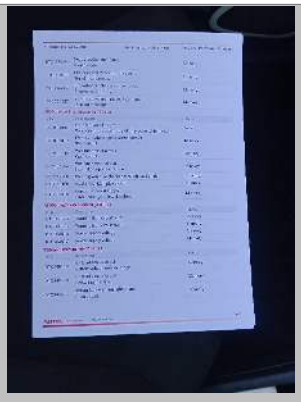
Shock and brake report

Left	Right		
	Braking Force [KN]	Braking Force [KN]	Axle Weight [KG]	Deceleration [m/s²]
Front	3.0	3.3	-	
Rear	2.1	2.6	-	
Emergency / Parking	0.8	1.2	-

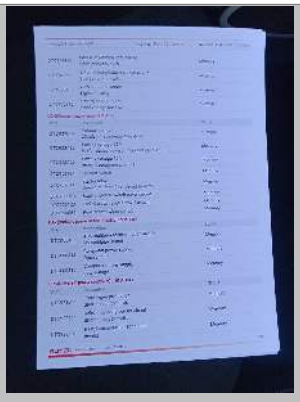
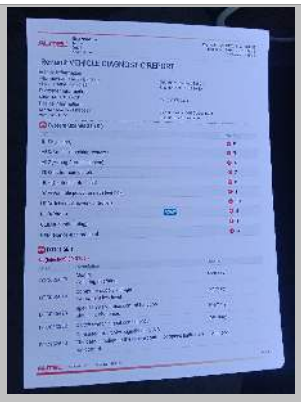
Diagnostic report

No	System	Code	Description	Status
1	MEMORY	DTC0300F8	MISFIRE POLLUTING MISFIRING

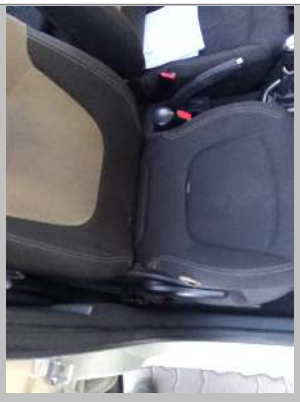
Damage	Repair Way
Caps Defective	Repair
Tail Light Right Damaged	Replace
Seat Front Right Torn / Cut	Repair
Front Bumper Damaged	Repair
Bonnet Dented	Repair
Rear Fender Left Paintwork • Scratched	Repair
Rear Fender Right Dented	Repair
Door Front Left Paintwork • Chipmarks	Repair
Door Front Right Paintwork • Scratched	Repair
Door Rear Left Paintwork • Scratched	Repair
Door Rear Right Paintwork • Scratched	Repair
Boot Lid / Hatch door Damaged	Repair
Rear bumper Damaged	Repair
Windscreen Cracked	Replace
Bolt(s) / Nut(s) Front Wheel Left Missing	Replace
Body exterior	Vehicle got some scratches, stone chips and dents
Boot not opening can not see spare wheel	Repair
Body exterior	Signs of spray work done on some body panels
Both front fender liner damage	Replace
