CONDITION REPORT

Report No:
2017317446
DATE
26/10/2026

Vehicle Type	PASSENGER VEHICLE	Registered Owner	MFC
Manufacturer	RENAULT	Registration Number	JT75BRGP
Model	SANDERO STEPWAY	Register Number	
VIN	VF15SRAAC64350511	Date Of First Licensing	
Engine Number		Last COR	
Doors	5	License Expiry Date	31/08/2026
Color	WHITE	Power / Displacement	
Year Model		Paint Finish	C - COMMON
Km Reading	190,290 KM	Fuel	PETROL
Cab / Body Type	HATCHBACK	Transmission	MANUAL

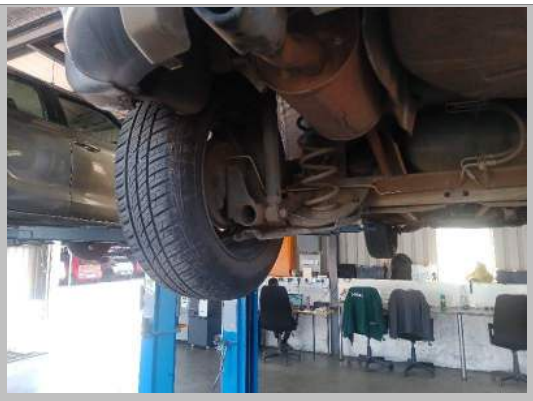
LF TYRE TREAD

Size	Load/Speed Index	Manufacture	Model	Type*	Production Date	Tread Depth (mm)
Front Left	205/55R16	91V	Royal black	Royal mile	V	1025	3 mm
Front Right	205/55R16	91V	Royal black	Royal mile	V	0325	3 mm
Rear Left	185/65R15	88T	Barum	Brilliants	V	4319	4 mm
Rear Right	205/55R16	91V	Continental	Contact	V	2724	3 mm
Spare	205/55R16	91V	Continental	Contact	V	0000	3 mm
