CONDITION REPORT

Report No:
2017315735
DATE
22/10/2026

Vehicle Type	PASSENGER VEHICLE	Registered Owner	
Manufacturer	RENAULT	Registration Number	KG23DFGP
Model	SANDERO	Register Number	
VIN	VF15SRAAC67500916	Date Of First Licensing	
Engine Number		Last COR	
Doors	5	License Expiry Date	31/05/2024
Color	BLUE	Power / Displacement	
Year Model		Paint Finish	M - METALLIC
Km Reading	53,123 KM	Fuel	PETROL
Cab / Body Type	HATCHBACK	Transmission	MANUAL

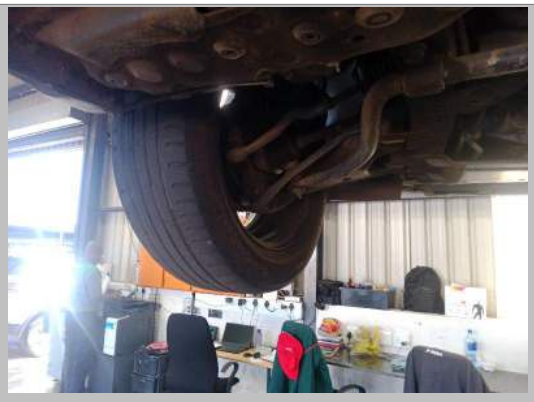
LF TYRE TREAD

Size	Load/Speed Index	Manufacture	Model	Type*	Production Date	Tread Depth (mm)
Front Left	205/55R16	91H	Continental	Contact	V	0721	1 mm
Front Right	205/55R16	91H	Continental	Contact	V	0521	1 mm
Rear Left	195/55R16	87H	Continental	Contact	V	1915	3 mm
Rear Right	195/55R16	87V	Continental	Contact	V	4614	3 mm
