CONDITION REPORT

Report No:
2017318441
DATE
28/10/2026

Vehicle Type	PASSENGER VEHICLE	Registered Owner	MFC AUCTION HOUSE
Manufacturer	RENAULT	Registration Number	HY98KZGP
Model	SANDERO	Register Number	
VIN	VF15SRLA462366200	Date Of First Licensing	
Engine Number		Last COR	
Doors	5	License Expiry Date	31/05/2026
Color	BLUE	Power / Displacement	
Year Model		Paint Finish	TWO COAT METALLIC
Km Reading	352,922 KM	Fuel	PETROL
Cab / Body Type	HATCHBACK	Transmission	MANUAL

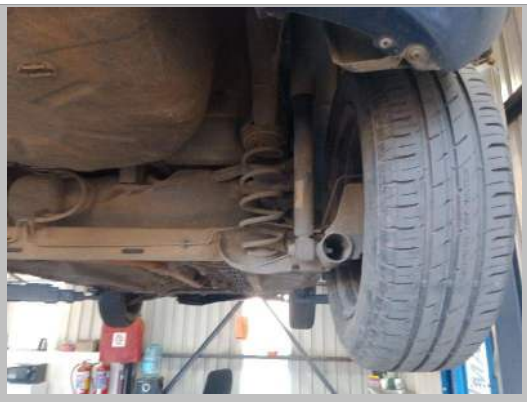
LR TYRE TREAD

Size	Load/Speed Index	Manufacture	Model	Type*	Production Date	Tread Depth (mm)
Front Left	185/65R15	88H	Firestone	Radial	V	1124	0 mm
Front Right	195/60R15	88T	Goodyear	Duraplus	V	2312	0 mm
Rear Left	195/65R15	91V	Giti	Radial	V	5021	2 mm
Rear Right	185/60R15	88H	General	Radial	V	2120	2 mm
