CONDITION REPORT

Report No:
2017314721
DATE
21/10/2026

Vehicle Type	PASSENGER VEHICLE	Registered Owner	MFC AUCTION HOUSE
Manufacturer	TOYOTA	Registration Number	KR21LGGP
Model	YARIS 1.0 XS 5-DR [2015-2016]	Register Number	
VIN	VNKKL0D3X0A173675	Date Of First Licensing	
Engine Number		Last COR	
Doors	5	License Expiry Date	31/12/2026
Color	BLUE	Power / Displacement	
Year Model	2015	Paint Finish	TWO COAT METALLIC
Km Reading	258,791 KM	Fuel	PETROL
Cab / Body Type	HATCHBACK	Transmission	MANUAL

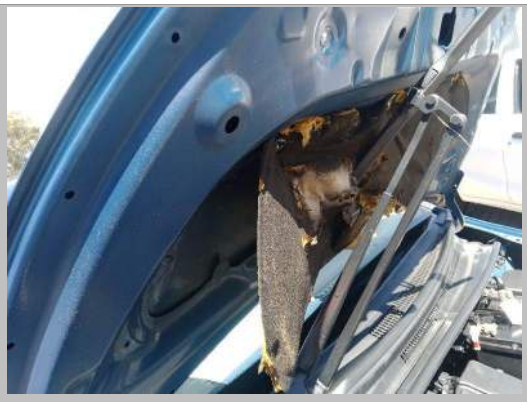
Damage	Repair Way
Bonnet stay and shocks Missing	Replace
Under bonnet insulation cover Damaged	Replace
Engine Management Lights Set	Repair
Switch Electrical Window Winder front right Damaged	Replace
Tail Light Right Damaged	Replace
Fog Light Front Left Damaged	Repair
Fog Light Front Right Damaged	Replace
Headlight Left Damaged	Replace
Headlight Right Damaged	Replace
Sun Visor Right Damaged	Replace
Side Mirror Right Damaged	Replace
Front Bumper Damaged	Repair
Bonnet Damaged	Repair
Front Fender Left Damaged	Repair
Front Fender Right Damaged	Repair
Rear Fender Left Damaged	Repair
Rear Fender Right Damaged	Repair
Door Front Left Damaged	Repair
Door Front Right Damaged	Repair
Door Rear Left Damaged	Repair
Door Rear Right Damaged	Repair
Boot Lid / Hatch door Damaged	Repair
Rear bumper Damaged	Repair
Roof Damaged	Replace
Windscreen Damaged	Replace
Tyre Rear Right Worn	Replace
