CONDITION REPORT

Report No:
2017317774
DATE
27/10/2026

Vehicle Type	PASSENGER VEHICLE	Registered Owner	
Manufacturer	OPEL	Registration Number	JNF001NW
Model	CORSA	Register Number	
VIN	W0L0XEP68G4001298	Date Of First Licensing	
Engine Number		Last COR	
Doors	5	License Expiry Date	
Color	GREY	Power / Displacement	
Year Model		Paint Finish	M - METALLIC
Km Reading	144,967 KM	Fuel	PETROL
Cab / Body Type	HATCHBACK	Transmission	MANUAL

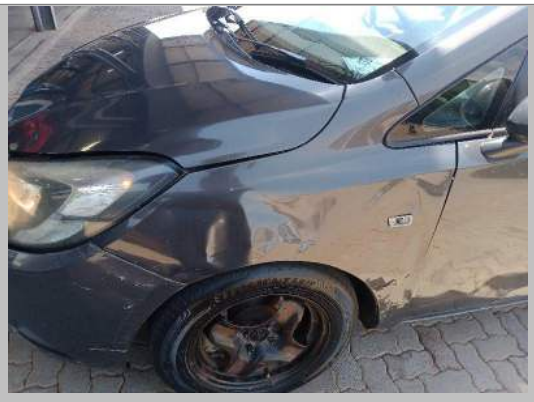
Damage	Repair Way
Engine Oil Leak	Repair
Expansion Bottle Water Leak	Replace
Windscreen Wiper Missing	Replace
Seat Front Right Damaged	Repair
Side Mirror Left Paintwork • Scratched	Repair
Side Mirror Right Paintwork • Scratched	Repair
Front Bumper Paintwork • Flaking	Repair
Bonnet Dented	Repair
A • Pillar Left Defective	Repair
A • Pillar Right Defective	Repair
Front Fender Left Dented	Repair
Front Fender Right Dented	Repair
Rear Fender Left Dented	Repair
Rear Fender Right Paintwork • Scratched	Repair
Door Front Left Paintwork • Scratched	Repair
Door Front Right Paintwork • Scratched	Repair
Door Rear Left Paintwork • Scratched	Repair
Door Rear Right Paintwork • Scratched	Repair
Boot Lid / Hatch door Dented	Repair
Rear bumper Paintwork • Scratched	Repair
Roof Paintwork • Discoloured	Repair
Windscreen Cracked	Replace
Tie Rod End right Damaged	Replace
Tyre Rear Left Damaged	Replace
Bolt(s) / Nut(s) Rear Wheel Left Missing	Replace

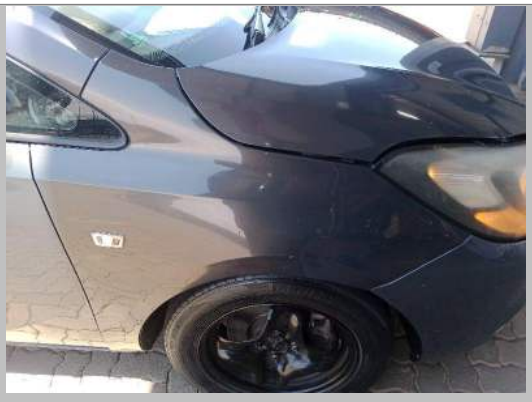
Door Rear Right

Bolt(s) / Nut(s) Rear Wheel Right Missing	Replace
Engine Smoke Excessive	Repair
Body exterior	Vehicle got some scratches, stone chips and dents
Body exterior	Discoloring on some body panels
ABS and traction control light on	Repair
Computer box loose	Repair
Signs of water leak	Repair
R/R tire deferred size	Repair
VCI plug malfunction	Repair
Front suspension noisy	Repair
