CONDITION REPORT

Report No:
2017312588
DATE
15/10/2026

Vehicle Type	PASSENGER VEHICLE	Registered Owner	
Manufacturer	MERCEDES-BENZ	Registration Number	KX03WBGP
Model	C200	Register Number	
VIN	W1K2060422R095756	Date Of First Licensing	
Engine Number		Last COR	
Doors	4	License Expiry Date	30/06/2027
Color	WHITE	Power / Displacement	
Year Model		Paint Finish	C - COMMON
Km Reading	147,114 KM	Fuel	PETROL
Cab / Body Type	SEDAN	Transmission	AUTOMATIC

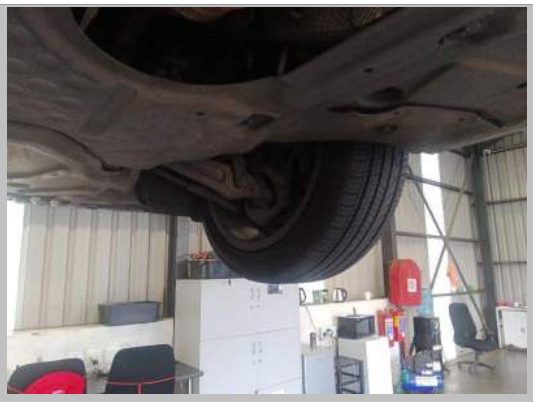
LF TYRE TREAD

Size	Load/Speed Index	Manufacture	Model	Type*	Production Date	Tread Depth (mm)
Front Left	225/45R18	95W	Anchee	Ac818	V	0526	3 mm
Front Right	225/45R18	95W	Anchee	Ac818	V	0526	3 mm
Rear Left	245/40R18	97W	Frun-two	Full run	V	0326	4 mm
Rear Right	245/40R18	97W	Frun-two	Full run	V	0326	4 mm

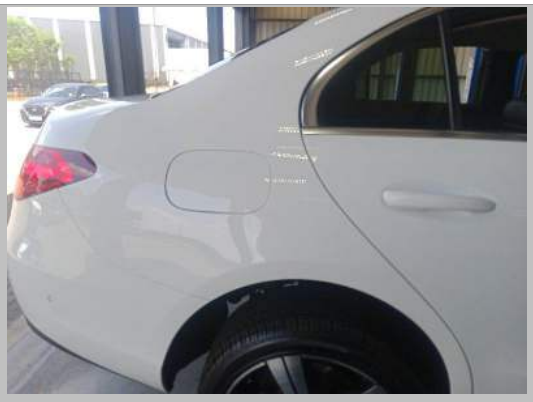
Damage	Repair Way
Front Bumper Paintwork • Scratched	Repair
Bonnet Paintwork • Chipmarks	Repair
Front Fender Left Paintwork • Scratched	Repair
Rear Fender Left Dented	Repair
Rear Fender Right Dented	Repair
Door Front Left Paintwork • Chipmarks	Repair
Door Front Right Dented	Repair
Door Rear Right Dented	Repair
Rear bumper Paintwork • Chipmarks	Repair
Engine light on	Repair
