CONDITION REPORT

Report No:
2017318943
DATE
29/10/2026

Vehicle Type	PASSENGER VEHICLE	Registered Owner	MFC AUCTION HOUSE
Manufacturer	AUDI	Registration Number	JB21WMGP
Model	A3 SPORTBACK 30 TFSI 5-DR S TRONIC [2018-2020]	Register Number	
		Date Of First Licensing	
VIN	WAUZZZ8V3KA081698	Last COR	
Engine Number		License Expiry Date	31/01/2026
Doors	5	Power / Displacement	
Color	WHITE	Paint Finish	TWO COAT UNI
Year Model	2019	Fuel	PETROL
Km Reading	211,418 KM	Transmission	AUTOMATIC
Cab / Body Type	HATCHBACK

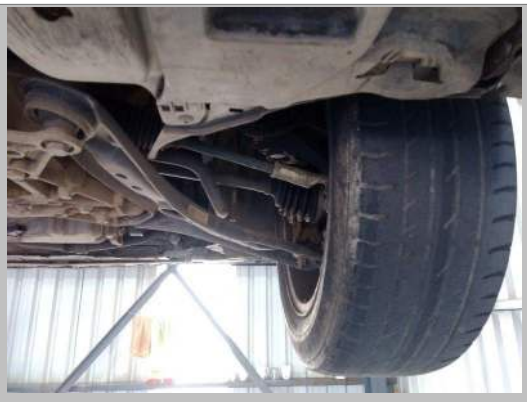
LF TYRE TREAD

Size	Load/Speed Index	Manufacture	Model	Type*	Production Date	Tread Depth (mm)
Front Left	205/55R16	91H	Hankook	Radial	V	1323	0 mm
Front Right	205/55R16	91V	Continental	Contipremiu	V	2515	0 mm
Rear Left	205/55R16	91V	wanli	Radial	V	3016	0 mm
Rear Right	205/55R16	91H	Hankook	Radial	V	4224	1 mm

Damage	Repair Way
Under bonnet insulation cover Damaged	Repair
Engine Management Lights Set	Repair
Seat Front Right Damaged	Repair
Front Bumper Damaged	Repair
Bonnet Damaged	Repair
Front Fender Left Damaged	Repair
Front Fender Right Damaged	Repair
Rear Fender Left Damaged	Repair
Rear Fender Right Damaged	Repair
Door Front Left Damaged	Repair
Door Front Right Damaged	Repair
Door Rear Left Damaged	Repair
Door Rear Right Damaged	Repair
Rear bumper Damaged	Repair
Sill Panel Left Damaged	Replace
Roof Damaged	Repair
Windscreen Damaged	Repair
Brake disc 1. Axle left Excessive Wear & Tear	Replace
Brake disc 1. Axle right Excessive Wear & Tear	Replace
Brake disc 2. Axle left Excessive Wear & Tear	Replace
Brake disc 2. Axle right Excessive Wear & Tear	Replace
Control Arm Bush(es) Front Axle Left Worn	Replace
Control Arm Bush(es) Front Axle Right Damaged	Replace
Tyre Front Left Worn	Replace
Tyre Front Right Worn	Replace
Tyre Rear Left Worn	Replace

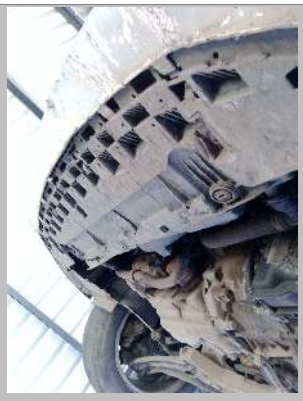
Radiator Cradle Damaged	Replace
Engine light illuminated	Repair
