CONDITION REPORT

Report No:
2017317280
DATE
28/10/2026

Vehicle Type	PASSENGER VEHICLE	Registered Owner	MFC
Manufacturer	AUDI	Registration Number	N/A
Model	A3 SEDAN 1.8T FSI SE S TRONIC [2013-2017]	Register Number	
VIN	WAUZZZ8V4F1065967	Date Of First Licensing	
Engine Number		Last COR	
Doors	4	License Expiry Date	31/03/2026
Color	WHITE	Power / Displacement	
Year Model	2015	Paint Finish	C - COMMON
Km Reading	218,290 KM	Fuel	PETROL
Cab / Body Type	SEDAN	Transmission	AUTOMATIC

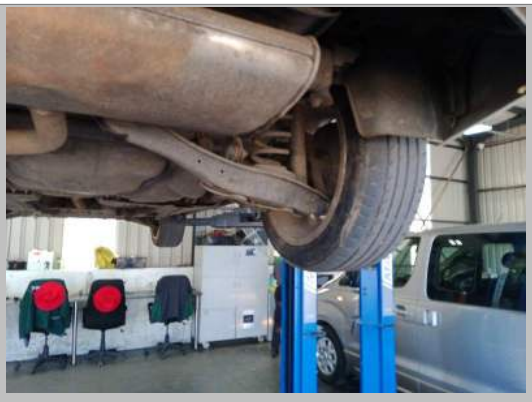
LR TYRE TREAD

Size	Load/Speed Index	Manufacture	Model	Type*	Production Date	Tread Depth (mm)
Front Left	255/45R17	94W	Powertrac	Racing pro	V	1624	3 mm
Front Right	225/45R17	94W	Rapid	Eco819	V	3922	0 mm
Rear Left	225/45R17	94W	Rapid	Eco819	V	3922	3 mm
Rear Right	225/45R17	94W	Rapid	Eco819	V	3922	3 mm
Spare	T125/70R18	99M	Continental	Temporary	V	////	4 mm

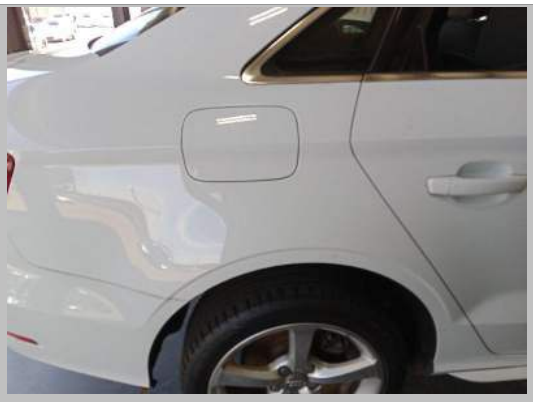
Damage	Repair Way
Water level Insufficient	Repair
Tail Light Left Damaged	Replace
Seat Front Right Damaged	Repair
Side Mirror Left Paintwork • Scratched	Repair
Front Bumper Damaged	Repair
Front Fender Left Paintwork • Scratched	Repair
Front Fender Right Paintwork • Scratched	Repair
Rear Fender Left Dented	Repair
Rear Fender Right Paintwork • Scratched	Repair
Door Front Left Paintwork • Scratched	Repair
Door Front Right Paintwork • Scratched	Repair
Door Rear Left Paintwork • Scratched	Repair
Door Rear Right Paintwork • Scratched	Repair
Boot Lid / Hatch door Dented	Repair
Rear bumper Paintwork • Scratched	Repair
Brake disc 1. Axle left Corrosion	Repair
Brake disc 1. Axle right Corrosion	Repair
Brake disc 2. Axle left Corrosion	Repair
Brake disc 2. Axle right Corrosion	Repair
Tyre Front Right Damaged	Replace
Engine Noise Excessive	Repair
Both number plates missing	Replace
Engine top cover missing	Replace
Engine light on	Repair
