CONDITION REPORT

Report No:
2017318082
DATE
27/10/2026

Vehicle Type	PASSENGER VEHICLE	Registered Owner	MFC AUCTION HOUSE
Manufacturer	AUDI	Registration Number	LM38VMGP
Model	A4 35 TFSI 110KW S TRONIC [2020-2021]	Register Number	
VIN	WAUZZZF41MA023487	Date Of First Licensing	
Engine Number		Last COR	
Doors	4	License Expiry Date	31/12/2026
Color	WHITE	Power / Displacement	
Year Model	2021	Paint Finish	TWO COAT UNI
Km Reading	202,811 KM	Fuel	PETROL
Cab / Body Type	SEDAN	Transmission	AUTOMATIC

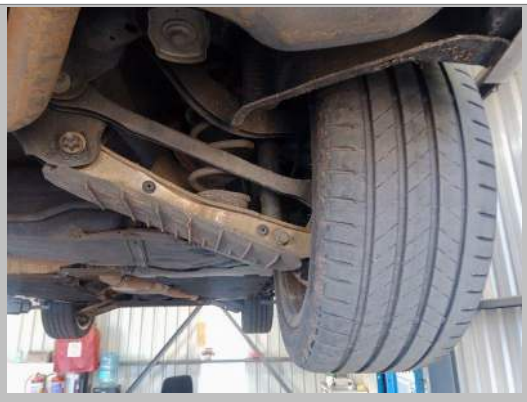
LF TYRE TREAD

Size	Load/Speed Index	Manufacture	Model	Type*	Production Date	Tread Depth (mm)
Front Left	245/40R18	97Y	Ceat	Radial	V	3224	2 mm
Front Right	245/40R18	97Y	Ceat	Radial	V	3223	2 mm
Rear Left	245/40R18	97Y	Bridgestone	Radial	V	4224	2 mm
Rear Right	245/40R18	97Y	Bridgestone	Radial	V	4224	2 mm

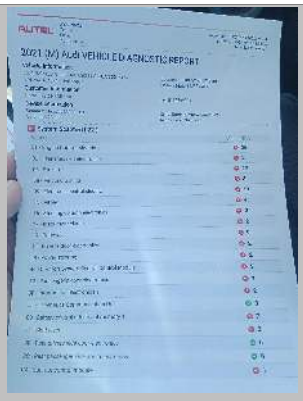
Diagnostic Report page 1

During the diagnostic the following error messages were detected: (See also attached Diagnostic Report. For more information regarding the Fault Codes (DTC) and the recommended rectifications please contact the workshops of the vehicle manufacture).

General Comments: ACCORDING TO THE AGE AND MILEAGE OF THE VEHICLE, NORMAL WEAR AND TEAR MARKS ARE VISIBLE ON THE INTERIOR, EXTERIOR, ELECTRICAL AND MECHANICAL PARTS.SIGNS OF REPAIR WORK DONE TO BODY PANELS. POOR ALIGNMENT TO SOMEBODY PANELS. 100 DTC'S AT TIME OF TESTING SEE DTC REPORT.
