CONDITION REPORT

Report No: 2016198931

DATE
12/12/2023

Vehicle Type	**PASSENGER VEHICLE**	Registered Owner	**MFC**
Manufacturer	**AUDI**	Registration Number	**JZ57WCGP**
Model	**Q2 TFSI**	Register Number	
VIN	**WAUZZZGA2HA025100**	Date Of First Licensing	
Engine Number		Last COR	
Doors	**5**	License Expiry Date	**30/06/2024**
Color	**GREY**	Power / Displacement	
Year Model		Paint Finish	**TWO COAT METALLIC**
Km Reading	**109,223 KM**	Fuel	**PETROL**
Cab / Body Type	**STATION WAGON**	Transmission	**AUTOMATIC**

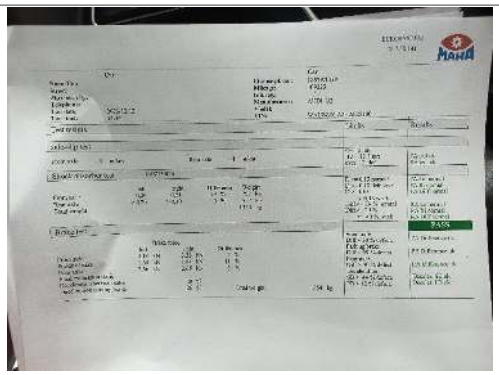
Brake and shock test

Left	Right		
	Braking Force [KN]	Braking Force [KN]	Axle Weight [KG]	Deceleration [m/s²]
Front	3.18	3.26	-	
Rear	2.56	2.65	-	
Emergency / Parking	1.64	1.84	-

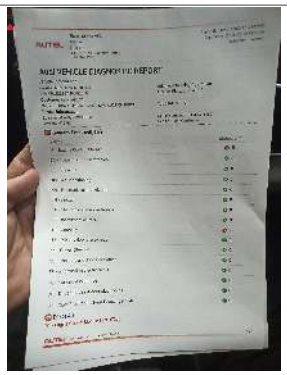
Diagnostic report

During the diagnostic no active error messages were detected. (See also attached Diagnostic Report. For more information regarding the Fault Codes (DTC) and the recommended rectifications please contact the workshops of the vehicle manufacture).
