CONDITION REPORT

Report No:
2017305420
DATE
30/09/2026

Vehicle Type	PASSENGER VEHICLE	Registered Owner	MFC
Manufacturer	BMW	Registration Number	FR27CRGP
Model	228I COUPE SPORT LINE 8-SP AT [2014-2016]	Register Number	
VIN	WBA1F52050VZ36502	Date Of First Licensing	
Engine Number		Last COR	
Doors	2	License Expiry Date	30/06/2026
Color	WHITE	Power / Displacement	
Year Model	2016	Paint Finish	C - COMMON
Km Reading	216,226 KM	Fuel	PETROL
Cab / Body Type	COUPE	Transmission	AUTOMATIC

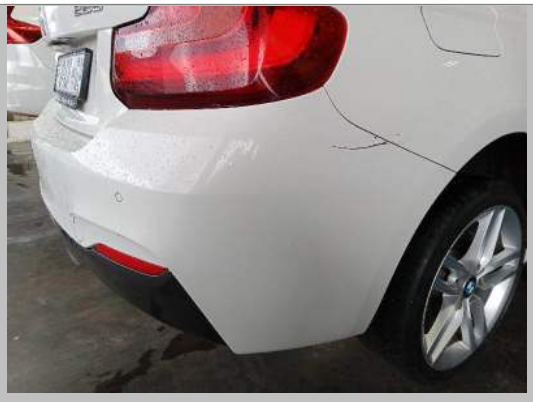
Damage	Repair Way
Engine Oil Leak	Repair
Headlight Right Damaged	Replace
Seat Front Right Torn / Cut	Repair
Front Bumper Paintwork • Scratched	Repair
Front Fender Right Dented	Repair
Rear Fender Left Dented	Repair
Rear Fender Right Dented	Repair
Door Front Left Paintwork • Scratched	Repair
Door Front Right Paintwork • Scratched	Repair
Rear bumper Paintwork • Scratched	Repair
Windscreen Chipped	Repair
Parking Brake Performance Left / Right Difference out of legal range	Repair
Shock Absorber Front Left Leak	Replace
Bolt(s) / Nut(s) Front Wheel Left Missing	Replace
Bolt(s) / Nut(s) Rear Wheel Left Missing	Replace
Gearbox Oil Leak	Repair
All four tires deferred name brand	Repair
