CONDITION REPORT

Report No:
2017316488
DATE
23/10/2026

Vehicle Type	PASSENGER VEHICLE	Registered Owner	
Manufacturer	BMW	Registration Number	JTS498NW
Model	320I AT [2008-2013]	Register Number	
VIN	WBAPG56010NN55392	Date Of First Licensing	
Engine Number		Last COR	
Doors	4	License Expiry Date	31/08/2025
Color	BLUE	Power / Displacement	
Year Model	2011	Paint Finish	TWO COAT METALLIC
Km Reading	274,896 KM	Fuel	PETROL
Cab / Body Type	SEDAN	Transmission	AUTOMATIC

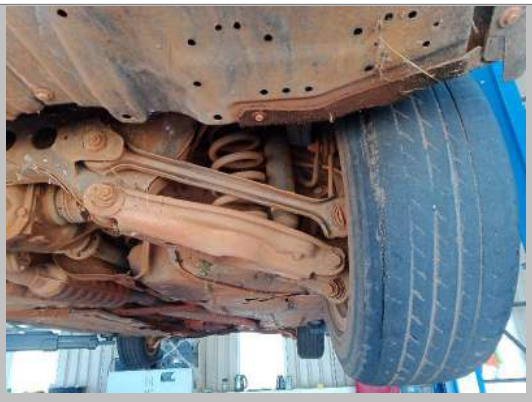
LR TYRE TREAD

Size	Load/Speed Index	Manufacture	Model	Type*	Production Date	Tread Depth (mm)
Front Left	205/55 R16	91V	Dunlop	Sport	V	4824	4 mm
Front Right	205/55 R16	91V	Dunlop	Sport	V	4824	4 mm
Rear Left	205/55 R16	91V	Dunlop	Sp-Sport	V	3219	0 mm
Rear Right	205/55Z R17	94W	Triangle	Talon	V	3706	0 mm

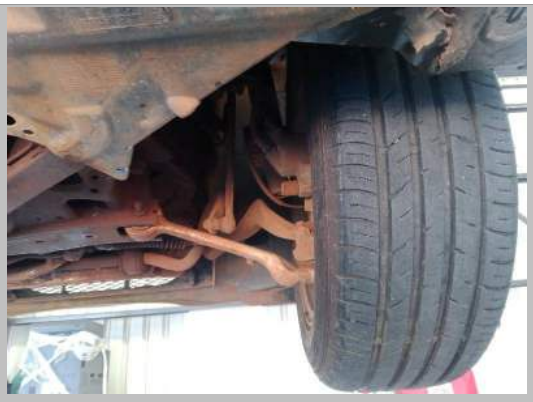
RR TYRE TREAD

Damage	Repair Way
Rear bumper stiffener damaged	Repair
ECU loose	Repair
Foreign substance on water cap	Repair
Rear tyres size differs	Replace
Warning light illuminated	Repair

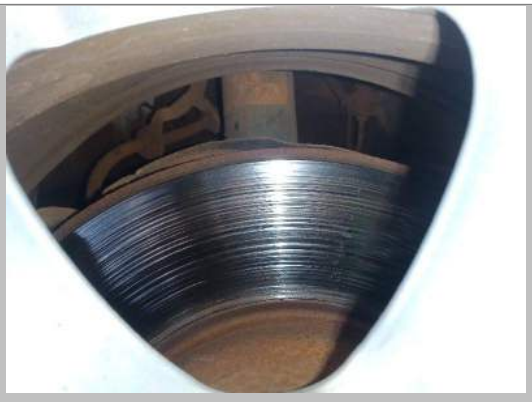
Side Mirror Right Paintwork • Scratched	Repair
Front Bumper Damaged	Repair
Bonnet Damaged	Repair
Front Fender Left Damaged	Repair
Front Fender Right Damaged	Repair
Rear Fender Left Damaged	Repair
Rear Fender Right Damaged	Repair
Front Fender Left / Inner Tray Damaged	Replace
Rear Fender Left / Inner Tray Damaged	Replace
Door Front Left Paintwork • Scratched	Repair
Door Front Right Residual Traces of Repair	Repair
Door Rear Left Paintwork • Scratched	Repair
Door Rear Right Residual Traces of Repair	Repair
Boot Lid / Hatch door Dented	Repair
Rear bumper Damaged	Repair
Sill Panel Left Paintwork • Scratched	Repair
Roof Damaged	Repair
Windscreen Cracked	Replace
Brake disc 1. Axle right Defective	Replace
Tyre Rear Left Damaged	Replace
Tyre Rear Right Damaged	Replace
Chassis Damaged	Repair
Engine to silencer pipe Defective	Repair
Catalytic converter Welded	Replace
Belly plates Damaged	Replace
Gearbox Oil Sweat	Repair
Engine Performance Insufficient	Repair
