CONDITION REPORT

Report No:
2017315979
DATE
23/10/2026

Vehicle Type	PASSENGER VEHICLE	Registered Owner	
Manufacturer	MERCEDES-BENZ	Registration Number	DP21DZGP
Model	CLA 200	Register Number	
VIN	WDD1173432N190739	Date Of First Licensing	
Engine Number		Last COR	
Doors	4	License Expiry Date	30/04/2025
Color	SILVER	Power / Displacement	
Year Model		Paint Finish	TWO COAT METALLIC
Km Reading	270,358 KM	Fuel	PETROL
Cab / Body Type	SEDAN	Transmission	AUTOMATIC

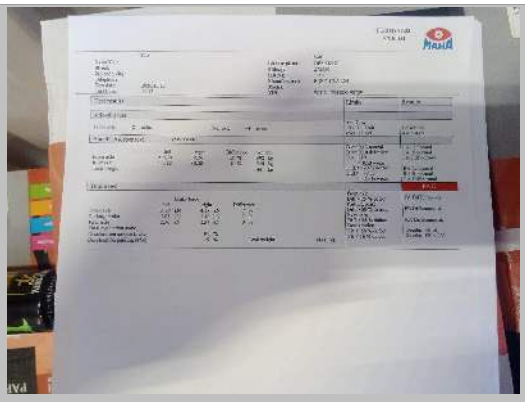
Brake test.

Left	Right		
	Braking Force [KN]	Braking Force [KN]	Axle Weight [KG]	Deceleration [m/s²]
Front	3.89	4.17	-	
Rear	2.36	2.37	-	
Emergency / Parking	1.02	1.1	-

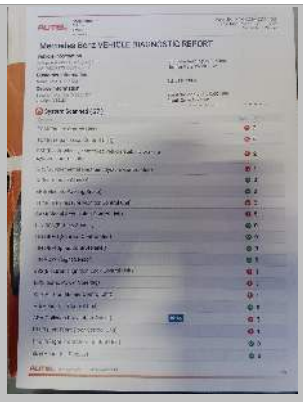
Diagnostic.

No	System	Code	Description	Status
1	ECM	P13C523	A SHORT-TERM TORQUE LIMITATION WAS DETECTED BY THE KNOCK CONTROL.

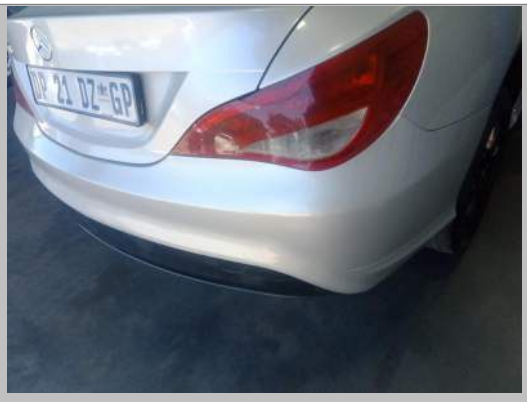
Damage	Repair Way
Engine Oil Leak	Repair
Engine Management Lights Set	Repair
Tail Light Right Damaged	Replace
Seat Front Right Damaged	Repair
Front Bumper Damaged	Repair
Bonnet Damaged	Repair
Front Fender Left Damaged	Repair
Front Fender Right Damaged	Repair
Rear Fender Left Damaged	Repair
Rear Fender Right Damaged	Repair
Door Front Left Damaged	Repair
Door Front Right Damaged	Repair
Door Rear Left Damaged	Repair
Door Rear Right Damaged	Repair
Boot Lid / Hatch door Damaged	Repair
Rear bumper Damaged	Repair
Windscreen Chipped	Repair
Tyre Front Left Worn	Replace
Tyre Front Right Worn	Replace
Gearbox Oil Leak	Repair

General Comments: ACCORDING TO THE AGE AND MILEAGE OF THE VEHICLE, NORMAL WEAR AND TEAR MARKS ARE VISIBLE ON THE INTERIOR, EXTERIOR, ELECTRICAL AND MECHANICAL PARTS.Body • Exterior: Signs of repair work done to body panels. Poor alignment to somebody panels. Vehicle body in poor condition. Repair work done to vehicle below standard.
