CONDITION REPORT

Report No:
2017317033
DATE
26/10/2026

Vehicle Type	PASSENGER VEHICLE	Registered Owner	
Manufacturer	MERCEDES-BENZ	Registration Number	FX64TXGP
Model	C200 BLUEEFFICIENCY [2011-2014]	Register Number	
VIN	WDD2040482R236226	Date Of First Licensing	
Engine Number		Last COR	
Doors	4	License Expiry Date	31/01/2025
Color	WHITE	Power / Displacement	
Year Model	2012	Paint Finish	TWO COAT UNI
Km Reading	203,469 KM	Fuel	PETROL
Cab / Body Type	SEDAN	Transmission	AUTOMATIC

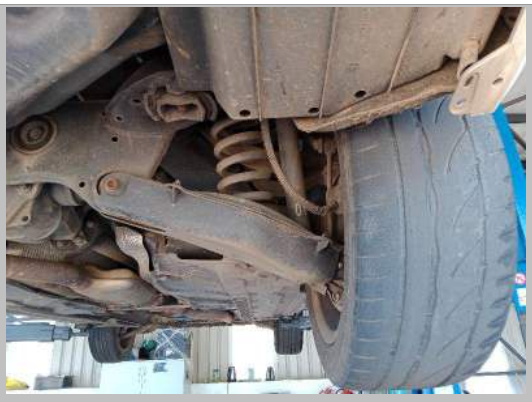
LR TYRE TREAD

Size	Load/Speed Index	Manufacture	Model	Type*	Production Date	Tread Depth (mm)
Front Left	225/45 R17	94W	Symmetry	SY400	V	4123	4 mm
Front Right	225/45 R17	94W	Symmetry	SY400	V	3023	5 mm
Rear Left	225/45 R17	94W	A-Three	P606	V	4921	2 mm
Rear Right	225/45 R17	91W	Bridgestone	Potenza	V	1416	1 mm
Spare	225/45 R17	91W	Firestone	Touring	V	1319	0 mm

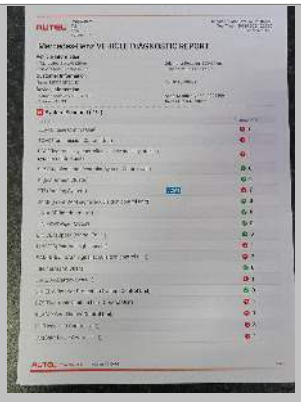
Diagnostic report page 1

No	System	Code	Description	Status
1	ECM(ENGINE CONTROL UNIT)	P001662	THE POSITION OF THE INTAKE CAMSHAFT(CYLINDER BANK1

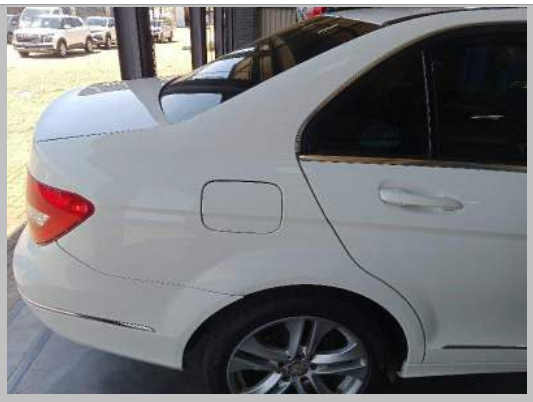
Damage	Repair Way
Engine Oil Leak	Repair
Hoses Defective	Replace
Air Conditioner Malfunction	Repair
Sun Visor Left Cracked	Repair
Brake Pedal Rubber Torn / Cut	Replace
Steering Wheel Trim Damaged	Repair
Front Bumper Paintwork • Scratched	Repair
Bonnet Paintwork • Chipmarks	Repair
Rear Fender Right Paintwork • Scratched	Repair
Front Fender Right / Inner Tray Damaged	Repair
Door Front Right Dented	Repair
Door Rear Right Dented	Repair
Boot Lid / Hatch door Paintwork • Scratched	Replace
Rocker Panel Right Paintwork • Scratched	Repair
Windscreen Chipped	Repair
Stabilizer Mounting Front Right Damaged	Replace
Control Arm Bush(es) Front Axle Left Cracked	Replace
Control Arm Bush(es) Front Axle Right Cracked	Replace
Spare Tyre Worn	Replace
Rim Front Left Scratched	Repair
Rim Rear Left Scratched	Repair
Rim Rear Right Scratched	Repair
Belly plates Damaged	Repair
Gearbox Oil Sweat	Repair
Engine Performance Idling / Hunting	Repair
